2012 Monitoring Report Scott River Water Trust

June 2013

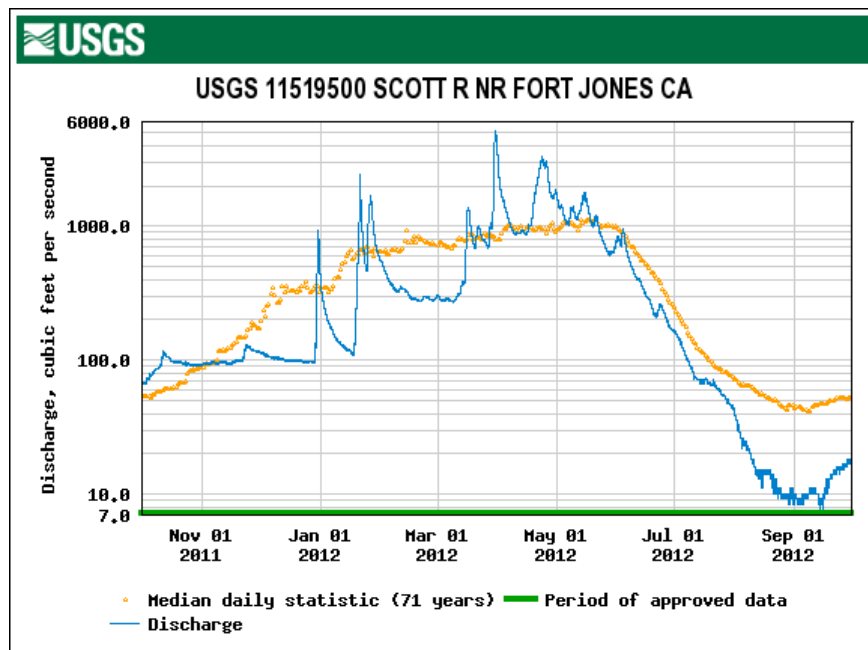
Figure 1. Scott River runoff during 2012 Water Year, Oct. 1, 2011 to Sept. 30, 2012 at USGS gage at river mile 21. (USGS 2012)

Although the previous year was quite wet, the 2012 water year transformed into a DRY water year type due to significantly below average rainfall and near average snowpack. Precipitation at Fort Jones for October 1, 2011 to April 1, 2012 was 13.92” or 79% of the average for that period, while Callahan’s records indicated 76%. Although the average water content of the snowpack for 5 sites was 101% on April 1st, it was reduced to 91% by May 1 and was only 62% at the lower elevation snowfield site above Etna Creek (CDWR 2012; USFS 2012). Runoff into the Scott River dropped below the median average (of 71 years of record) during much of the water year (Figure 1). Snowmelt caused some spikes but by late May, this below median runoff pattern continued through September and into the fall.

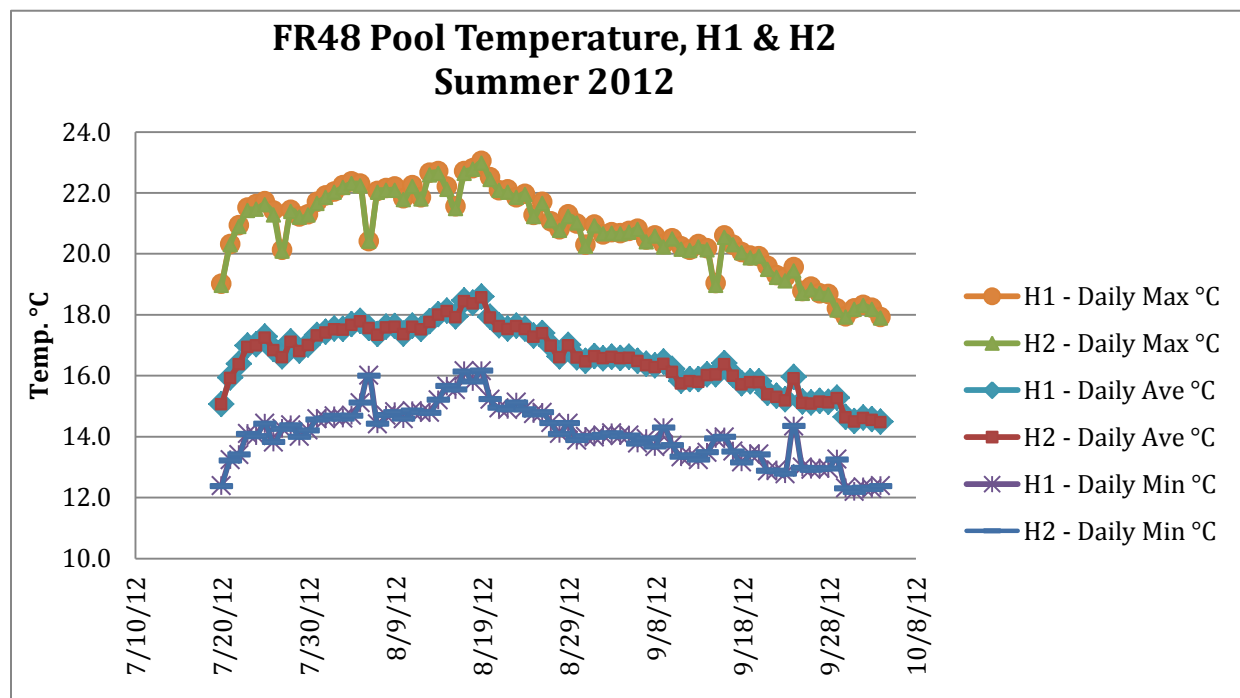
Figure 6: Daily maximum, minimum, and average water temperature, recorded by H1 and H2 HoboTemps in pool 20 ft. below POD.

The warmest day of the monitoring period was August 18th, when daily max was 23.0 °C. Coldest recorded temperature was September 30th, when the H2's Daily Min was 12.2 °C. Temperatures recorded by H1 and H2 were fundamentally the same – never more than 0.17°C difference - which shows the upper region of the pool is just slightly warmer than the deeper part. The lack of greater pool temperature stratification is likely due to the pool being well mixed.

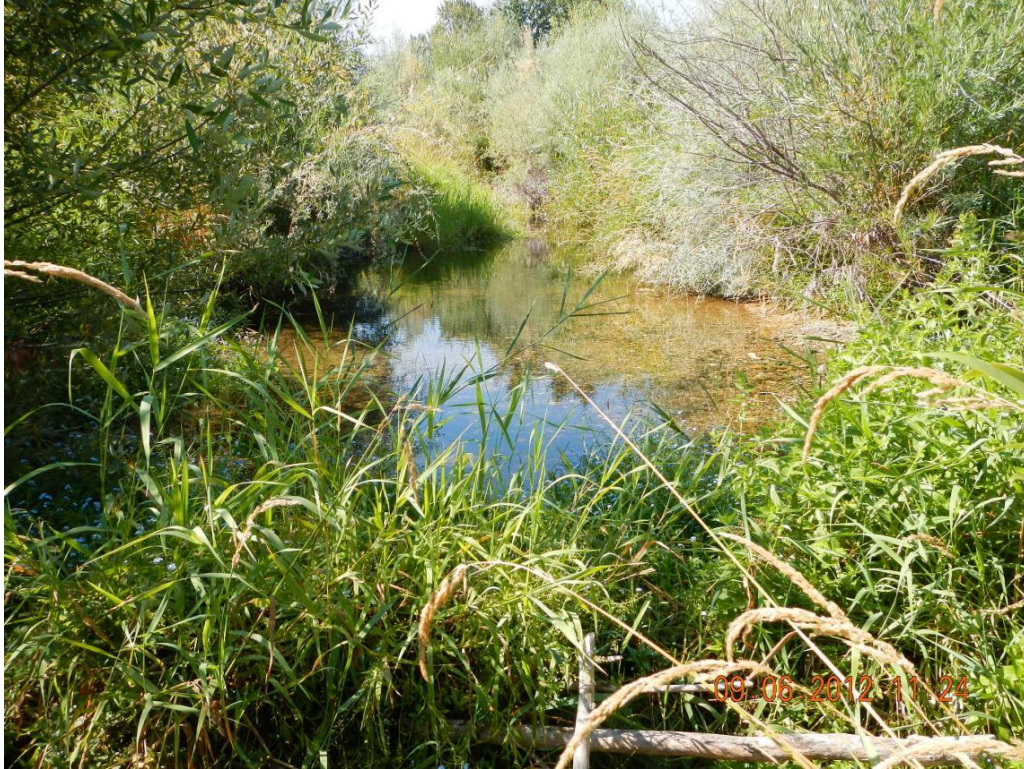
Figure 7. Lower French Creek: Beaver Dam #3

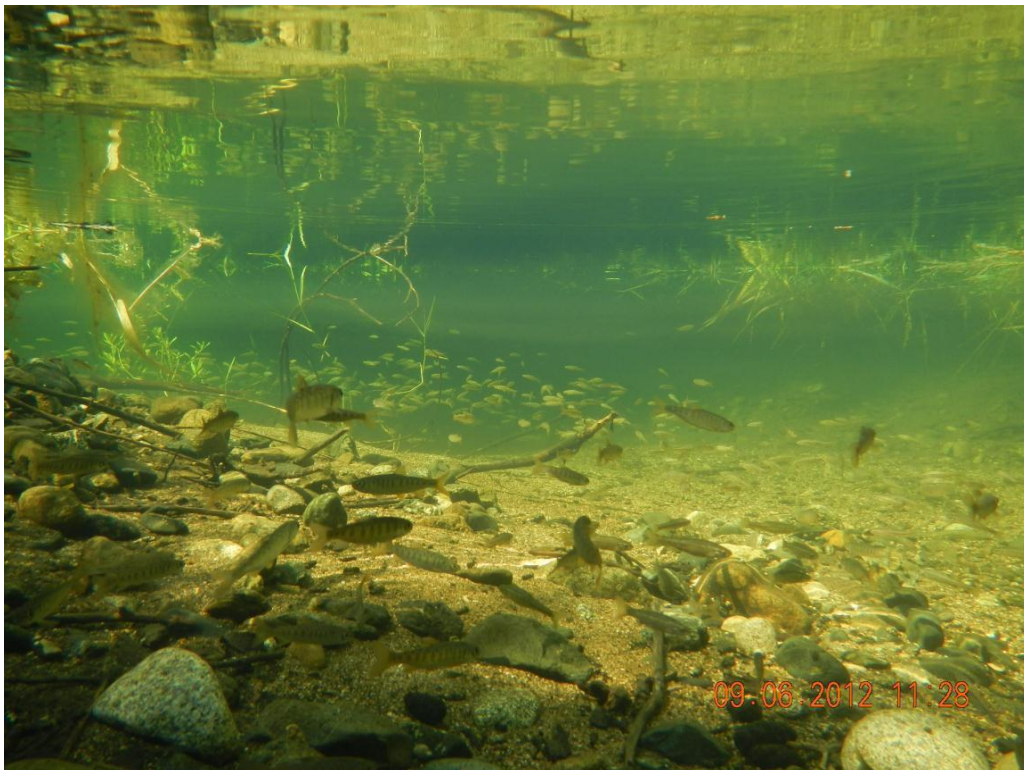
Figure 8. Lower French Creek: Density of 0+ coho, trout and dace in Beaver Dam #3 Pool

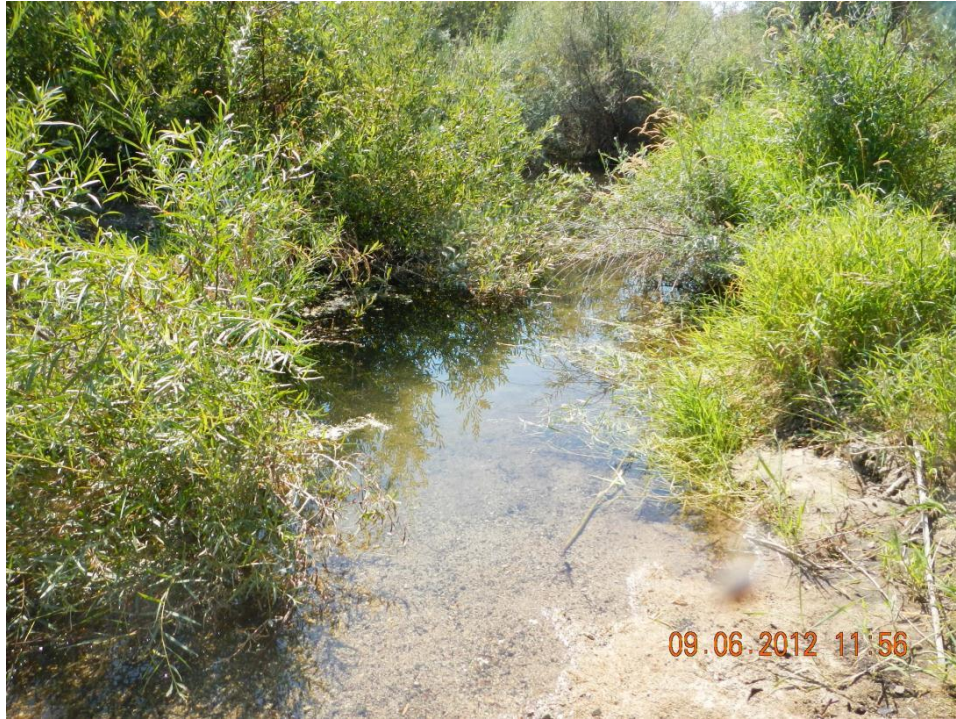
- Beaver Dam #2 was almost completely dry, including all of the willows which were flooded in early surveys. Only a small pool near the top held water, but seemed very cold, possibly fed by the Wolford Slough, which is adjacent to the south. Approximately 200 fish were using this covered pool: mostly 0+ Coho and trout, some dace and 2 1+ and 2+ trout.

Figure 9. French Creek: Remaining Pool at Top of Beaver Dam #2

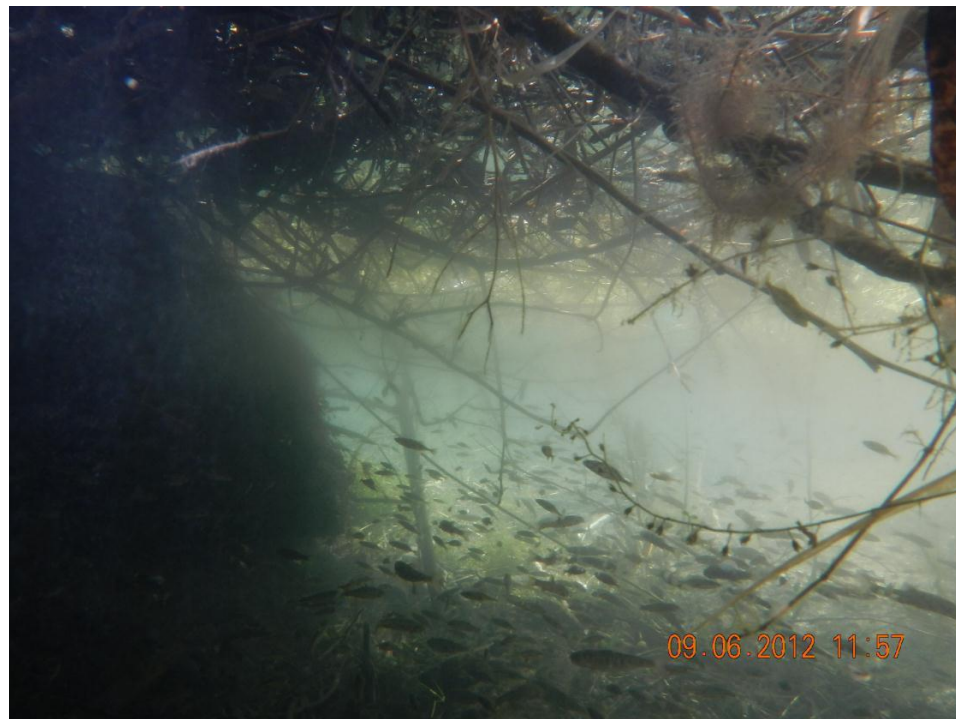
Figure 10. French Creek: 0+ Coho and trout in Remaining Pool at top of Beaver Dam #2

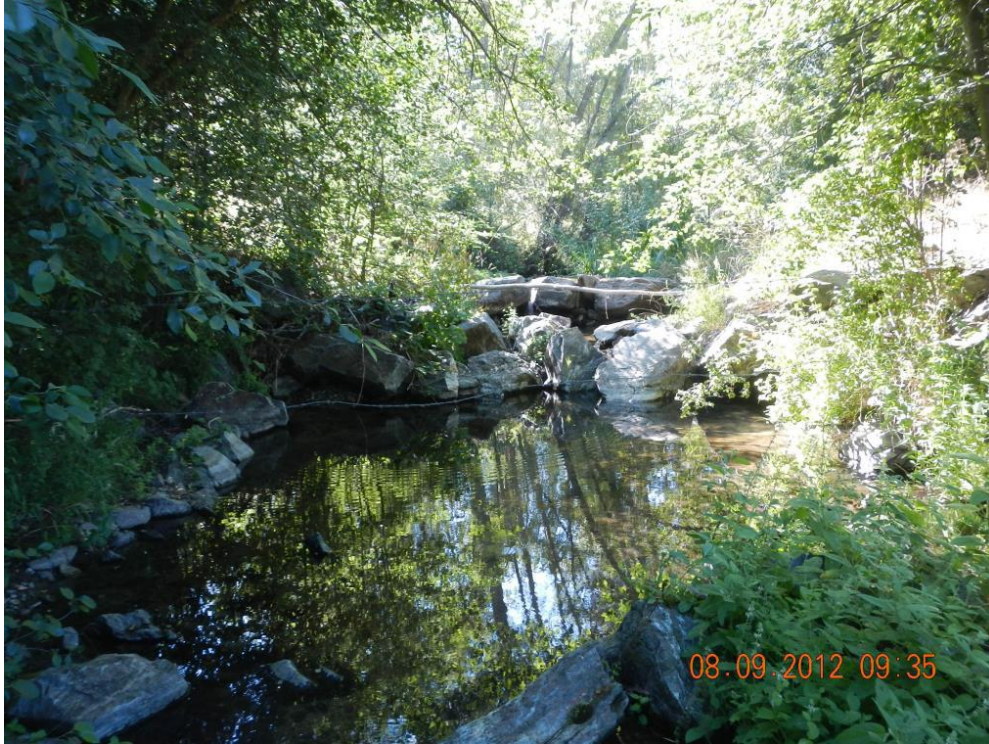
“Flows were quite low in Miners Creek at this time. The two artificial pool habitats just below the POD were snorkeled. Below the lower pool (Pool 2), was a shallow riffle. Constructed rock weirs formed the pools, the lower pool having the larger pool volume. Neither pool had much in-stream cover, except for large boulders. The substrate was primarily small granitic sand sized particles and boulders. Overhead canopy cover provided shading to the pools. The fish were very docile and did not try to move from the pools. The following fish were observed:

Figure 14: Miners Creek: Upper Reach below POD at Pool 2 (lower)

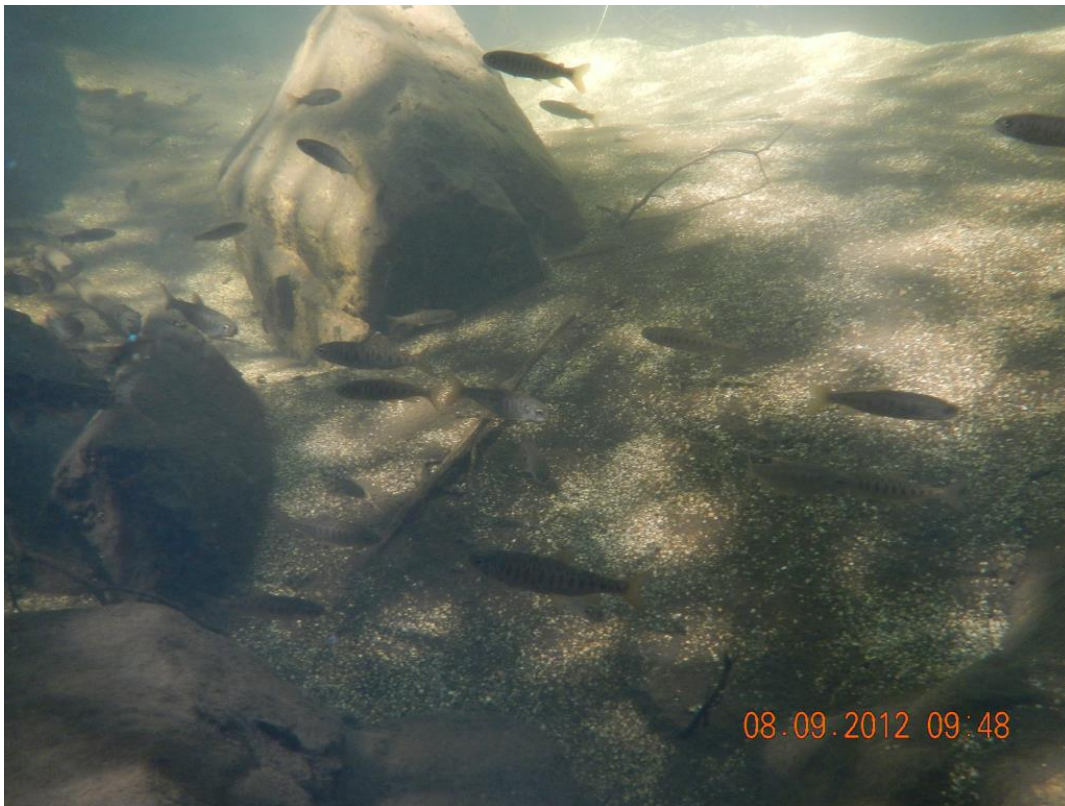
Figure 15: 0+ Coho salmon and 1+ trout intermixed in Pool 2

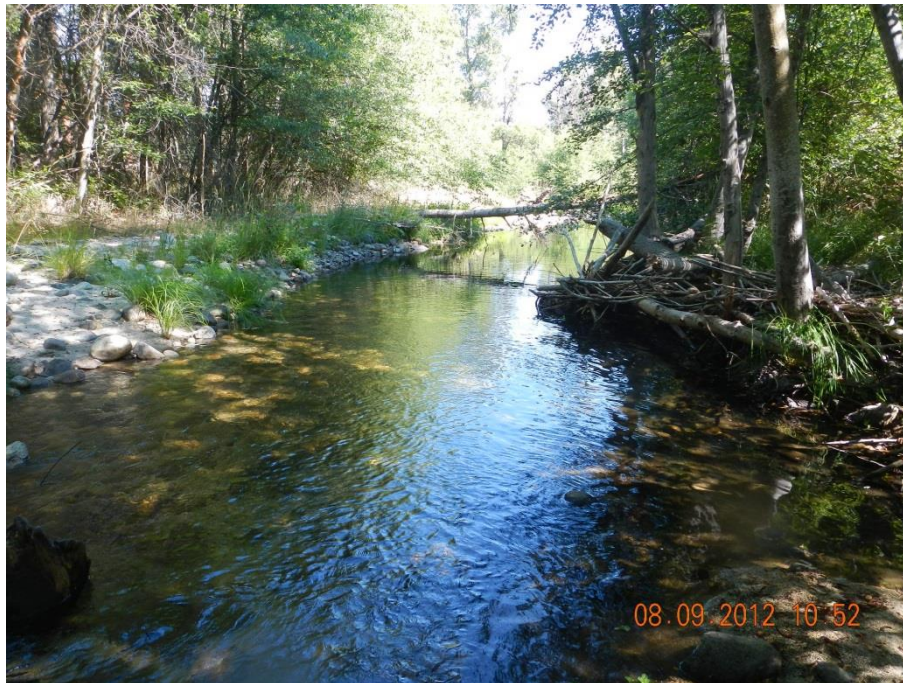
Figure 15. Confluence Pool in French Creek below Miners Creek confluence, 8/9/12.

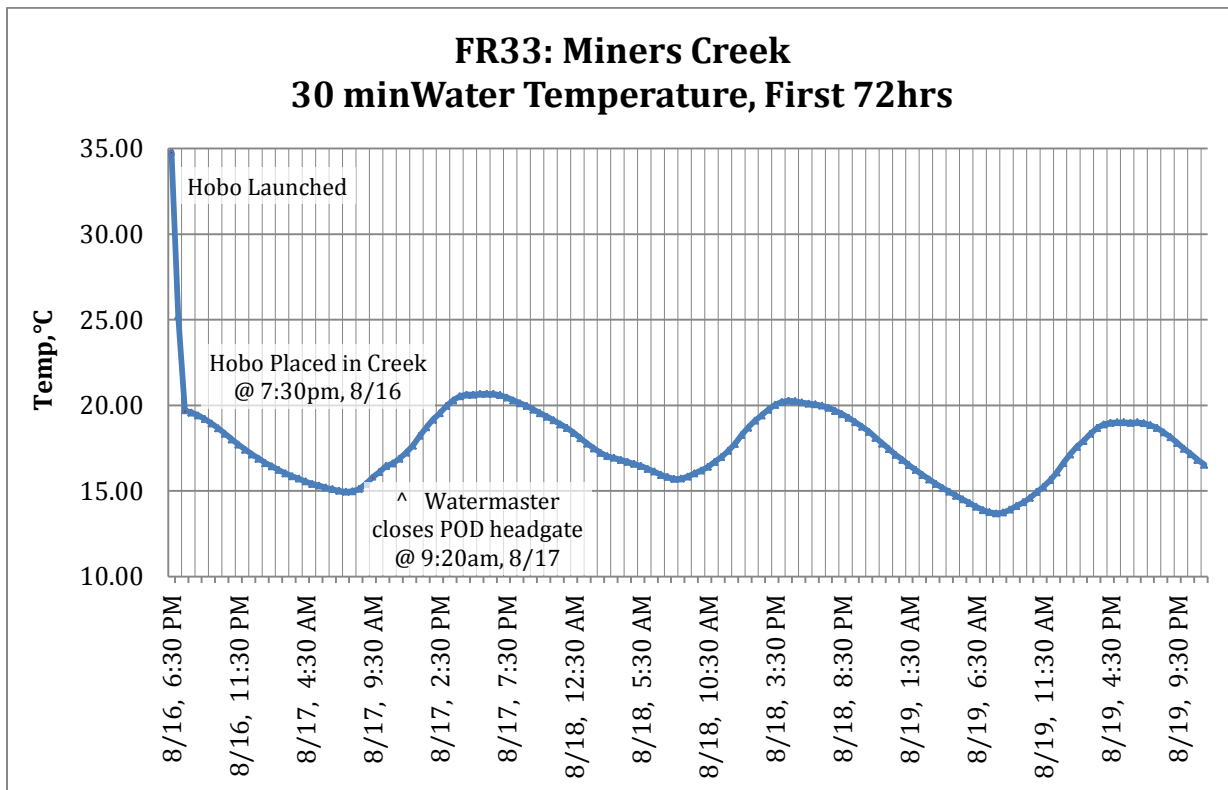
Figure 16: 30 minute water temperature data for 3 days around the start of transaction event.

During each day of the first 72 hours of the lease, daily water temperature fluctuated ~5 °C, between a maximum of ~20° C around 6 pm, and minimum of ~14.5° C around 8 am (Figure 16). The lease did not appear to have any effect on water temperature, as there is no visible shift in the smooth curves of normal temperature fluctuation.

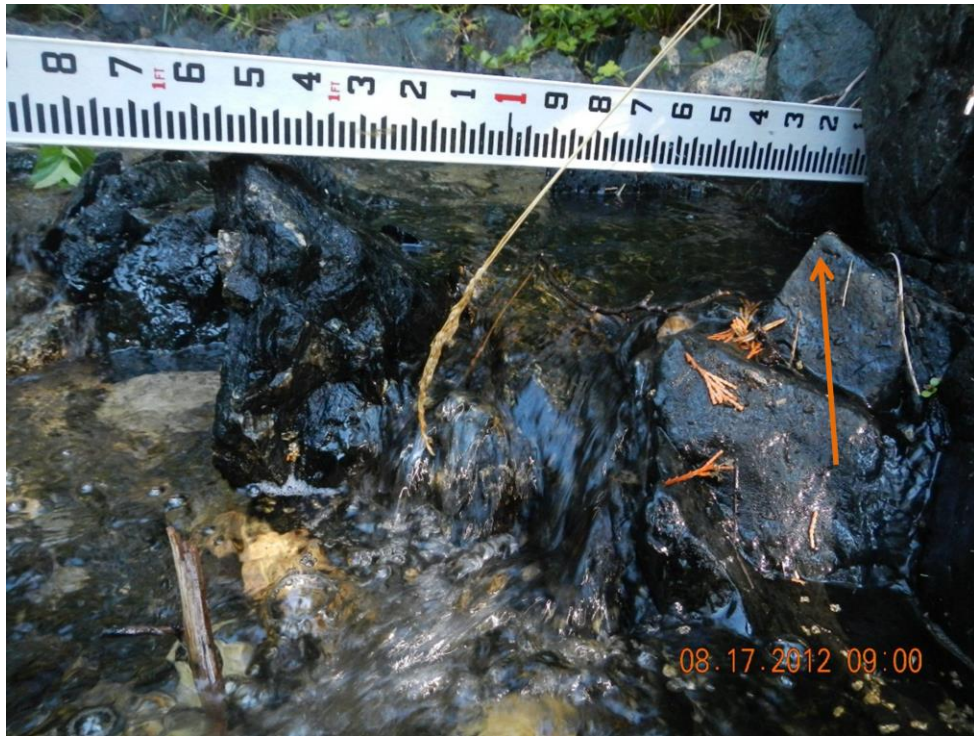
Figure 18: Miners Creek channel, 37 ft. below POD, 0.14 cfs before transaction

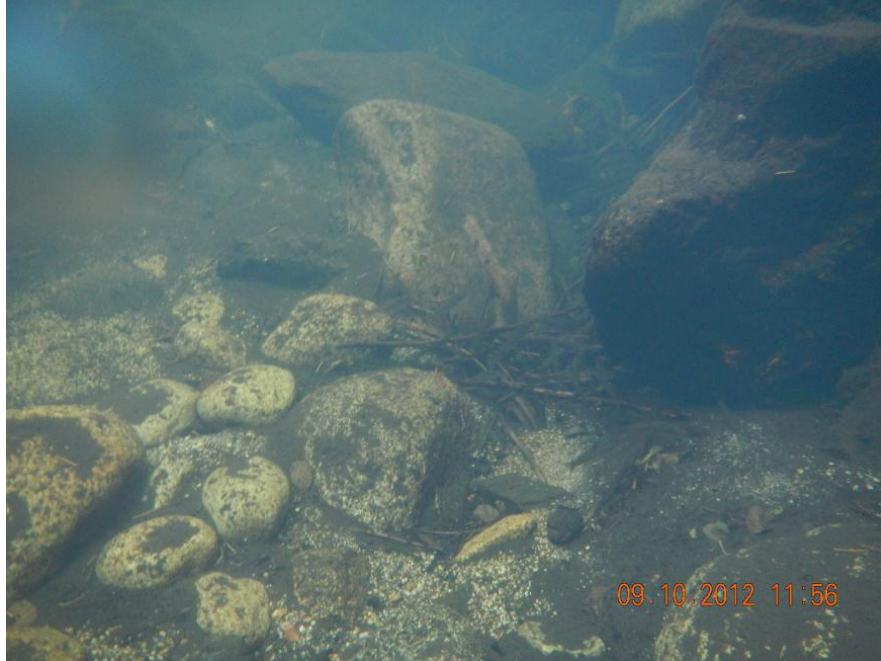
Figure 21: School of 0+ coho salmon in POD pool

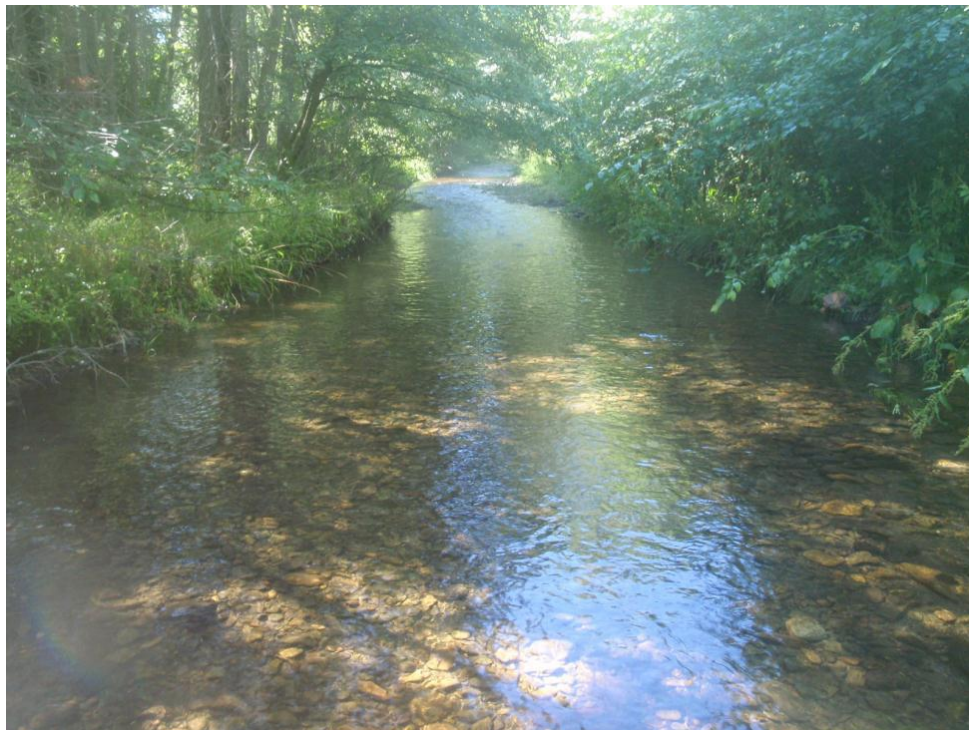
Figure 22. Typical run habitat, with shallow pool at top.

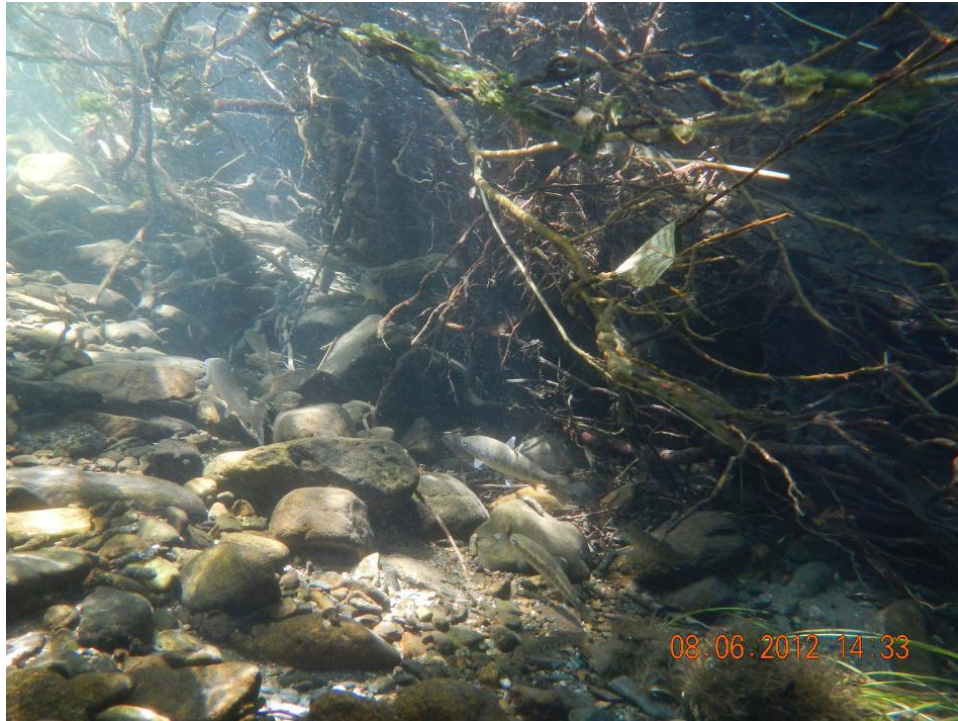
Figure 23. Trout using tree roots for cover.

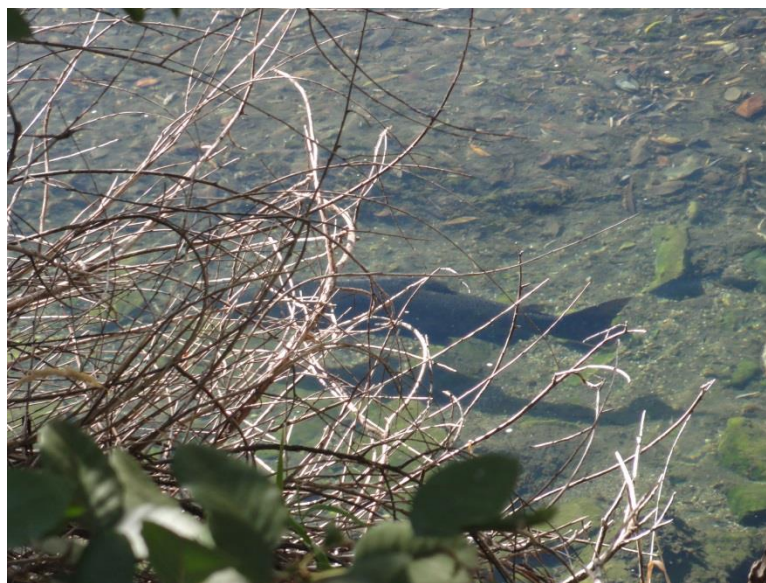
Figure 26. Chinook salmon adult observed below POD on 10/23.

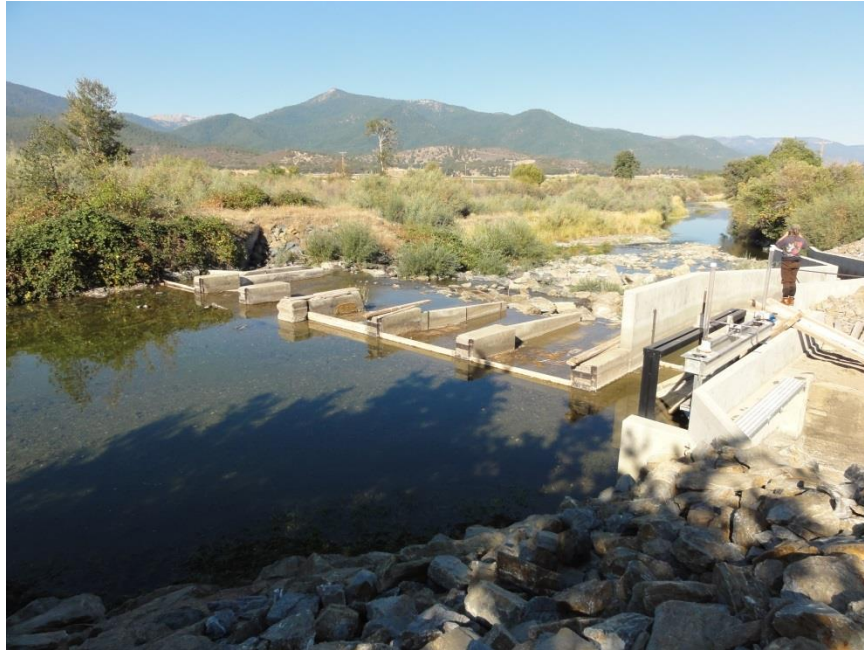
Figure 27. Scott River at Young's Dam and fish ladder on 10/1, start of lease.

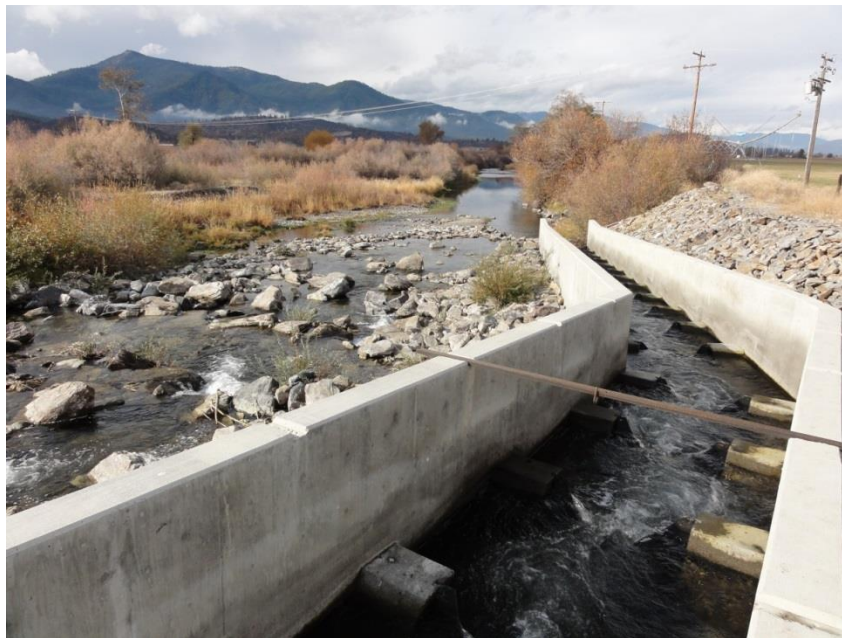
Figure 28. Scott River at Young's Dam and fish ladder on 11/13, end of lease.

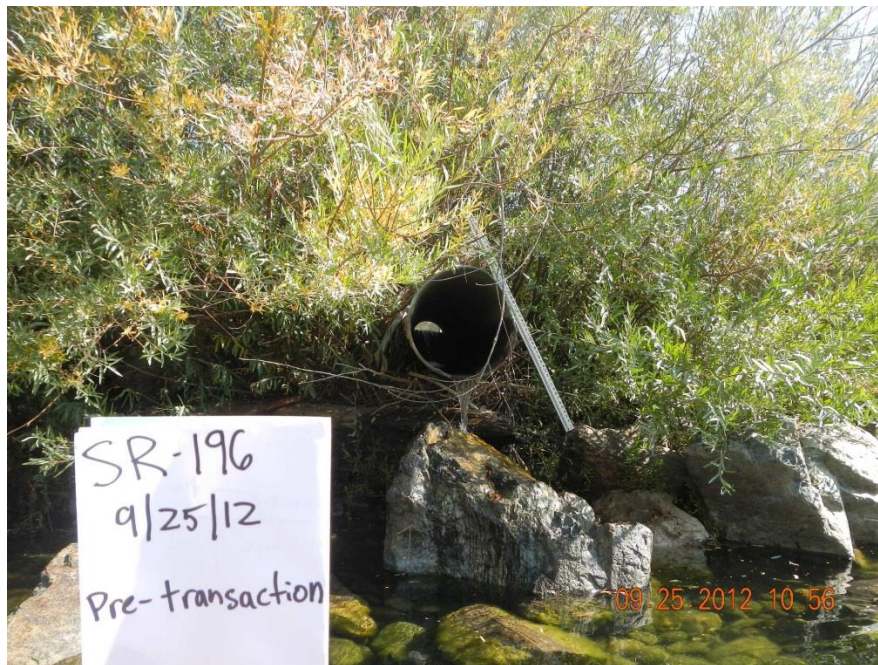
Figure 29: Scott River #196: Fish bypass outflow pipe, before transaction.

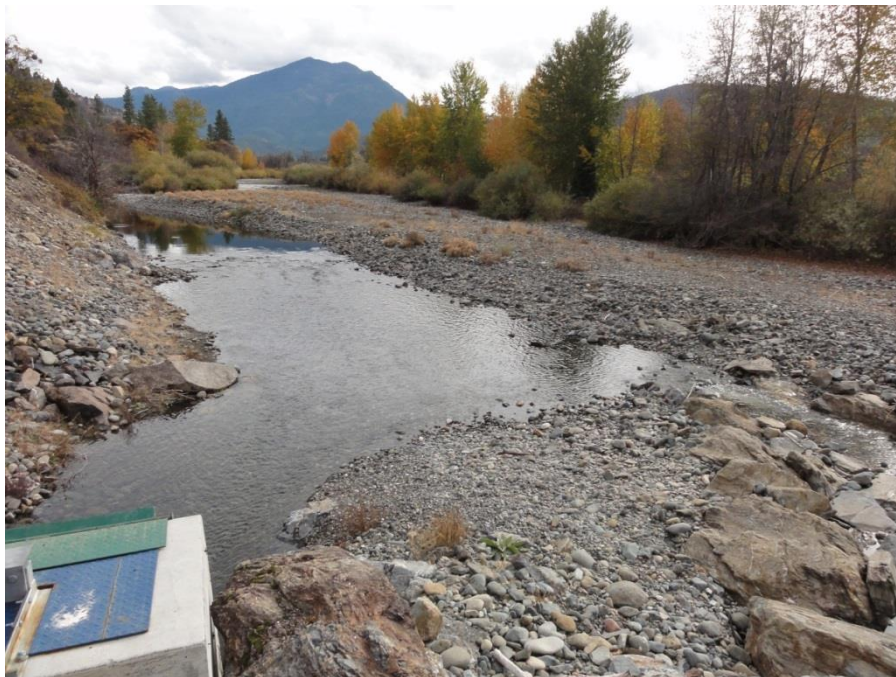
Figure 31. Scott River at Point of Diversion (left) on 11/13/12: BEFORE lease.

On the day of the transaction, 11/13, a ditch flow measurement was completed at 2:38 pm (ditch Q = 11.0 cfs), and a stream flow measurement was completed at 3:40 pm (stream Q = 6.0 cfs). At 4:26 pm, the fish bypass was opened, as instructed by the ditch tender, which released the majority of the diverted flows back into the stream with a small amount of flow still entering the ditch (~1 or 2 cfs). At 4:46 pm, the POD headgate was ratcheted down as much as possible, but could not be closed completely because woody debris obstructed the headgate from closing.

The next day (11/14), the contracted field technician, under the direction of the ditch tender, placed rocks and sandbags to stop flows from entering the fish screen, and direct more flows through the fish bypass. Woody debris was removed from the POD headgate and the headgate opening was reduced (though some immovable rocks kept the headgate from closing completely). The POD and fish screen remained in this state for the remainder of the lease period.

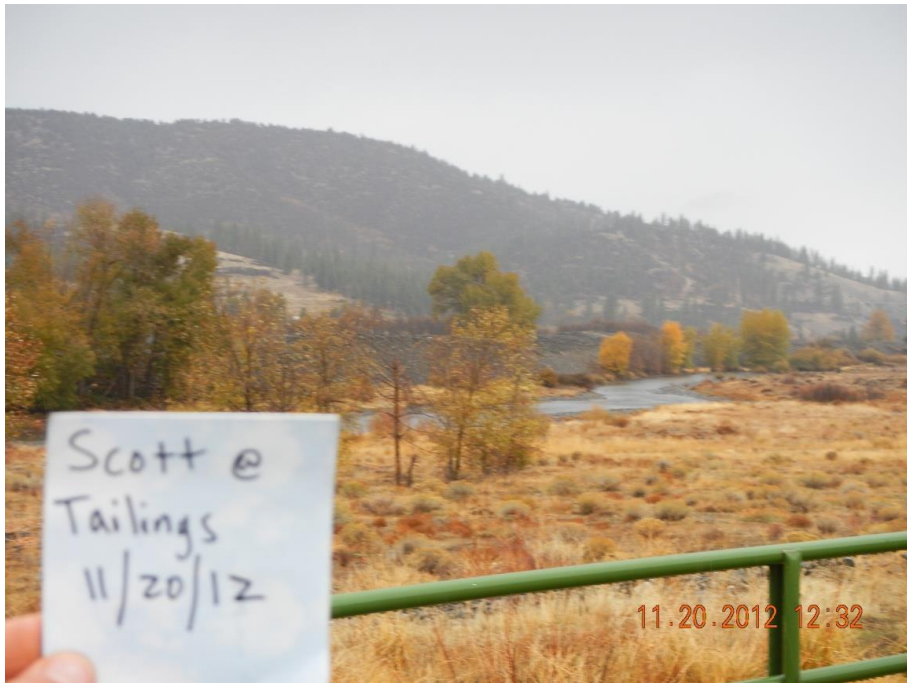
Figure 33: 11/20: 7 days after start of lease, and recent rain events, stream is connected @ RM 53.

On 11/16 and 11/20, photos of the disconnected reach below the SR183 POD were taken from the East Callahan Rd at the "Picture Location" (noted above) to monitor stream connectivity for fish passage. This depicted stream section is 1.6 miles below SR183 POD, or about RM 53. Sugar Creek's confluence with the Scott River is at RM 54.4.
