# *Scott River Main-stem Flow and Water Quality Monitoring Project (2023–2025)*

## 2024 Annual Report

*Prepared for: Siskiyou RCD. Prepared by: Evan Senf. Funding Provided by: California Department of Fish and Wildlife (CDFW) & Siskiyou Resource Conservation District (SRCD) (\$309,281.09).*

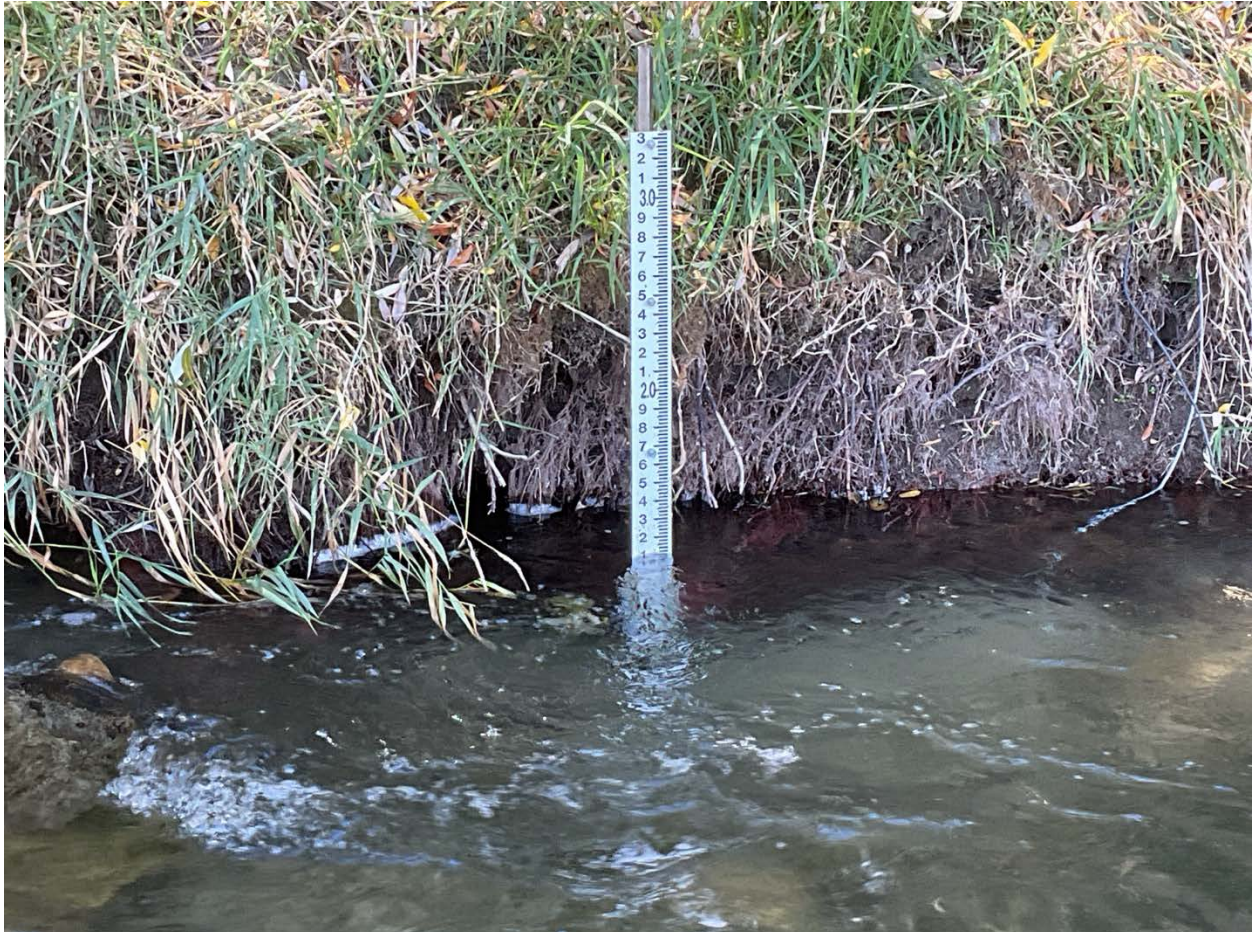
*Photo 1: 'Static' In-stream Staff Gage Installation, River-left, Meamber Bridge Site (SRCD, 9/24/24).*

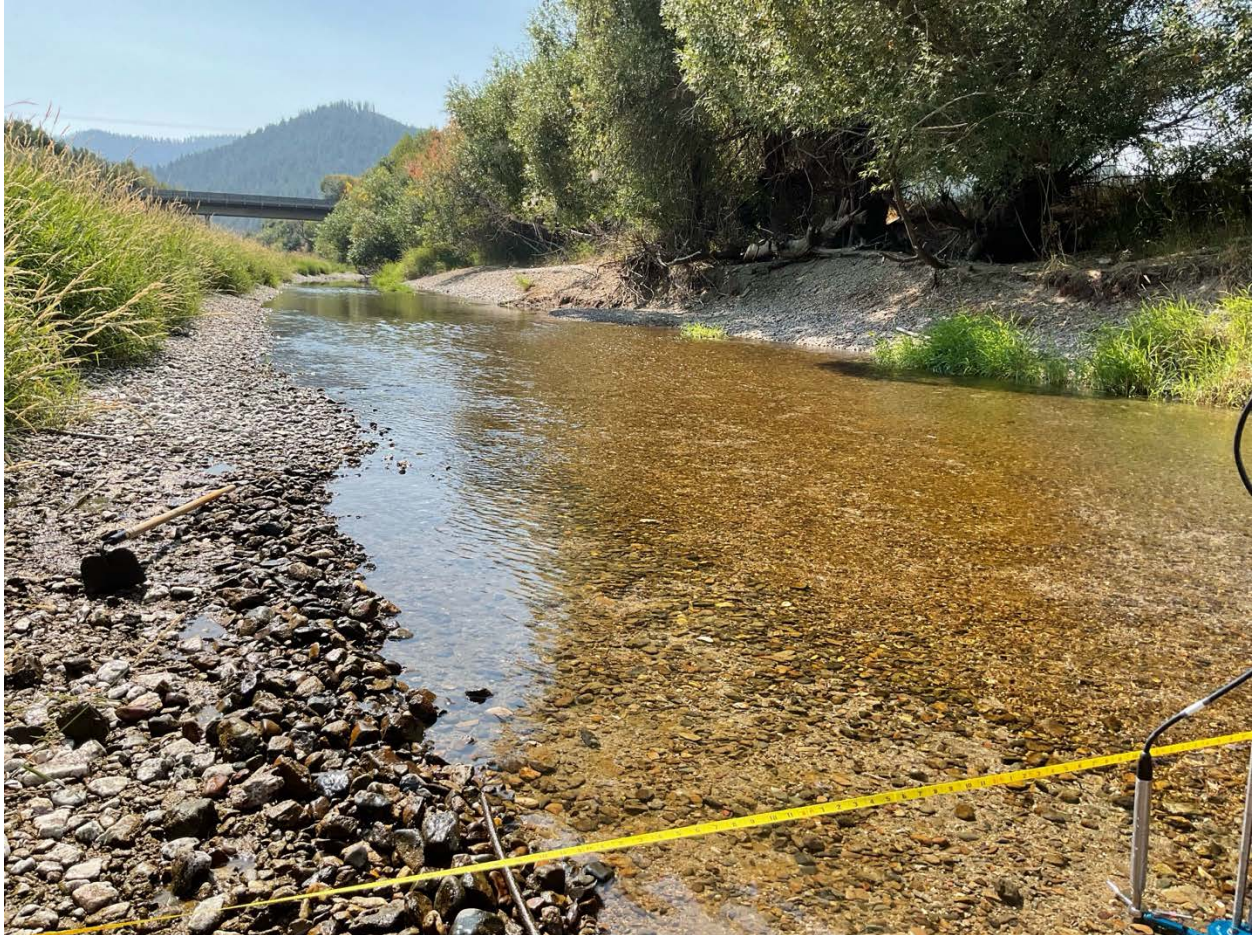
*Photo 2: Meamber site flow-measurement cross-section, looking upstream. (SRCD, 8/16/2024).*

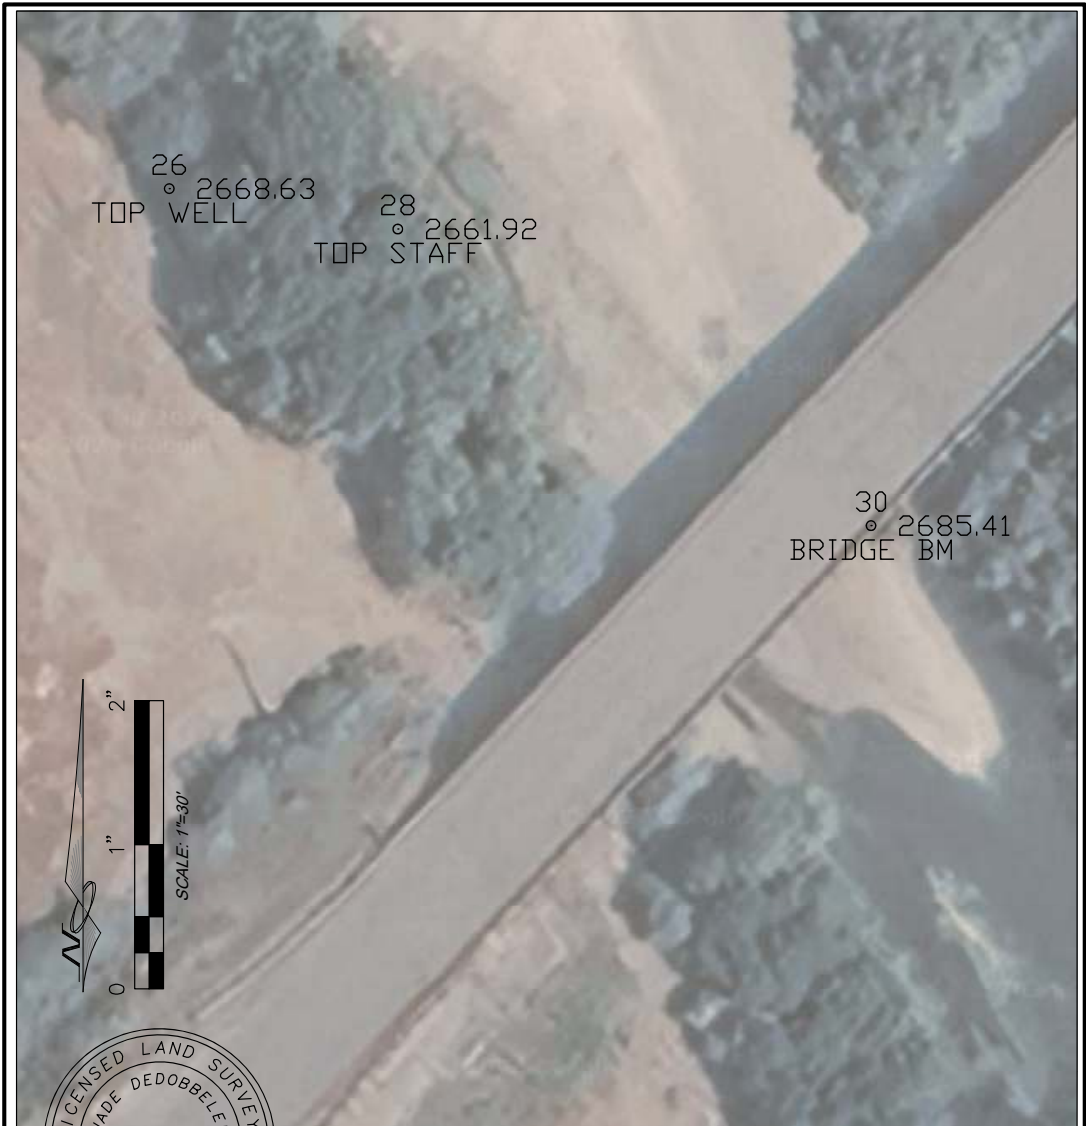
Map 1: Meamber Site

ELEVATIONS ARE NAVD88 BASED ON  
NGS BENCHMARK MX0434 (N838)

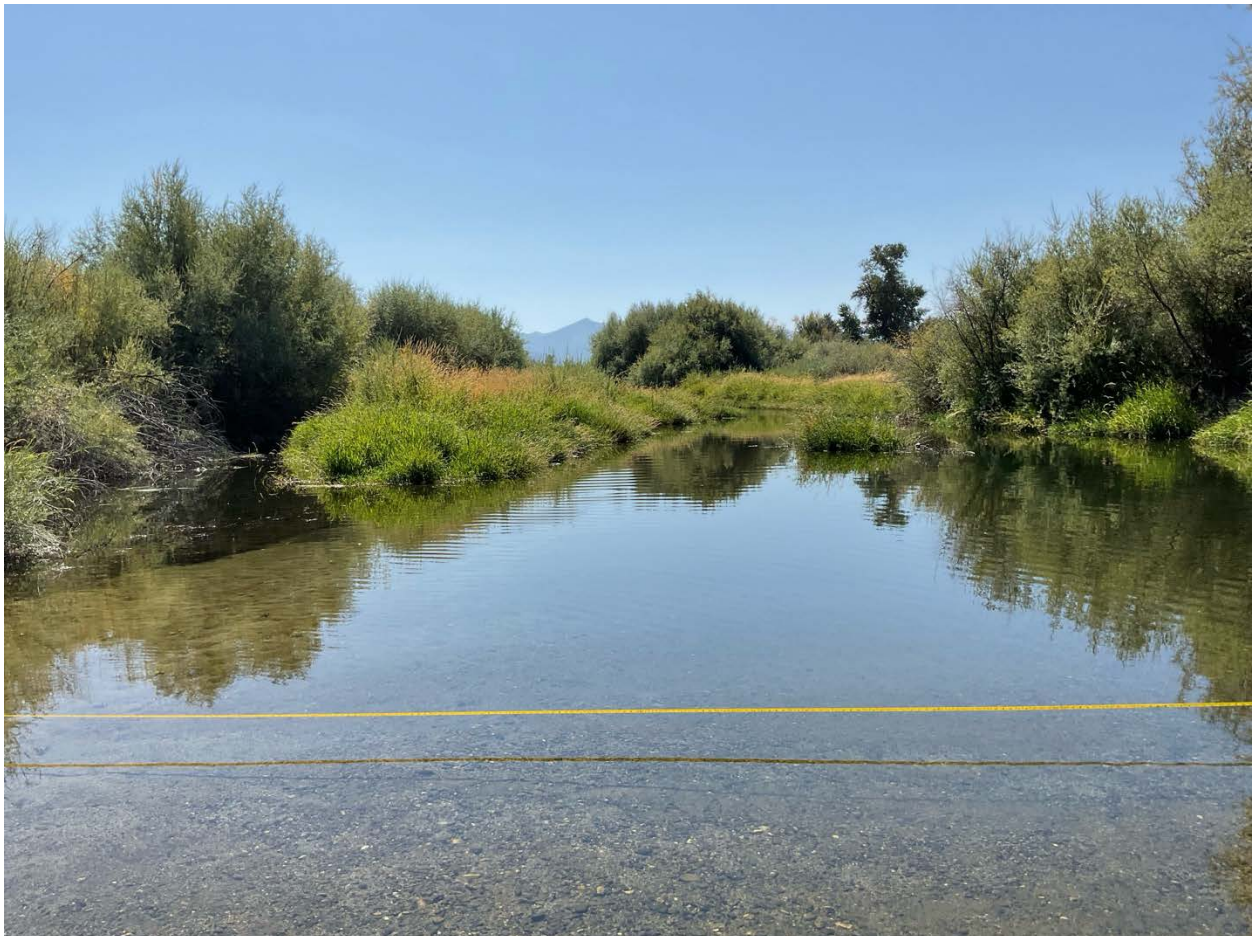
*Photo 3: Horn site flow-measurement cross-section, looking upstream. (SRCD, 8/30/2024).*

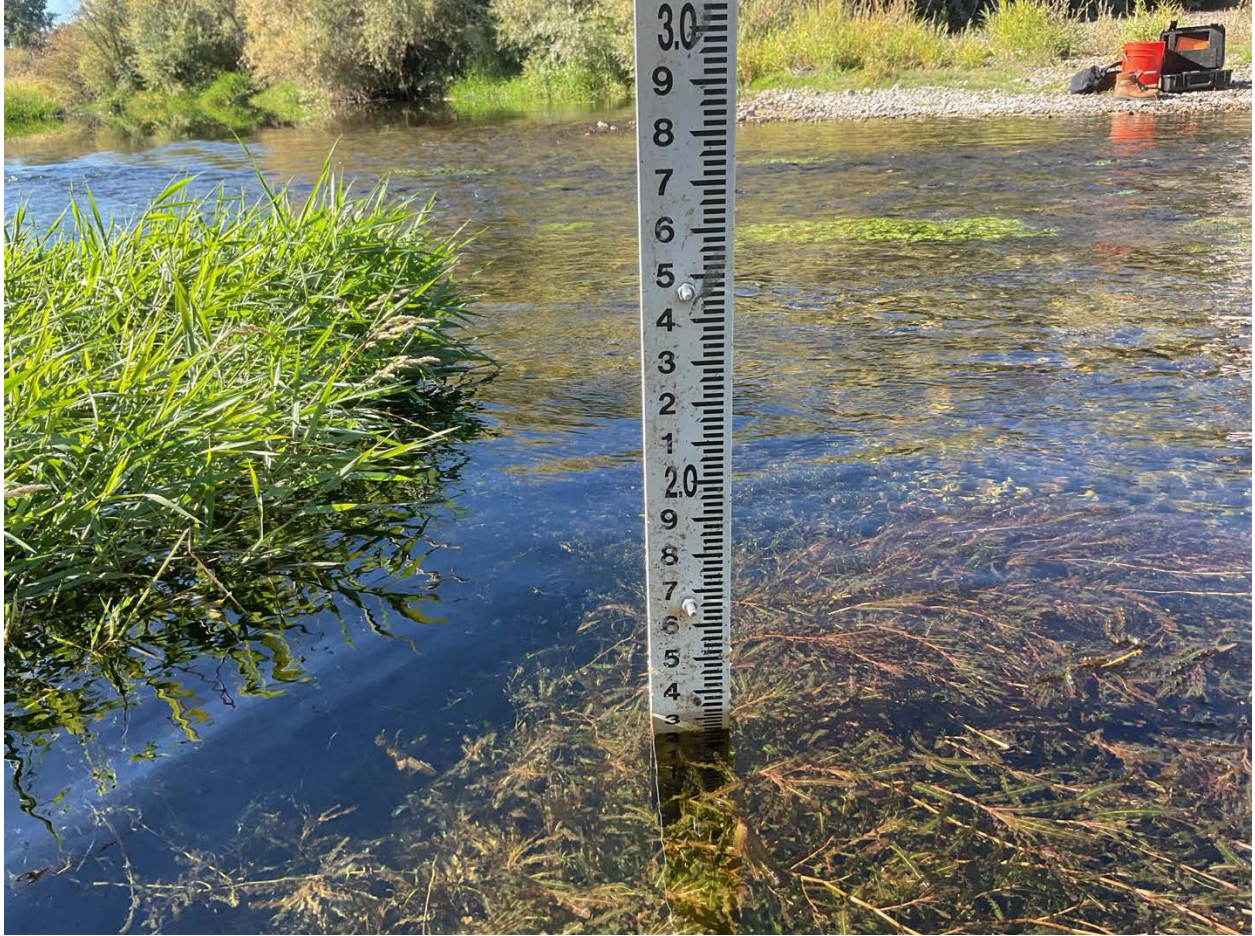
*Photo 3: Horn Site Static Staff Gage 1. (SRCD, 2024)*

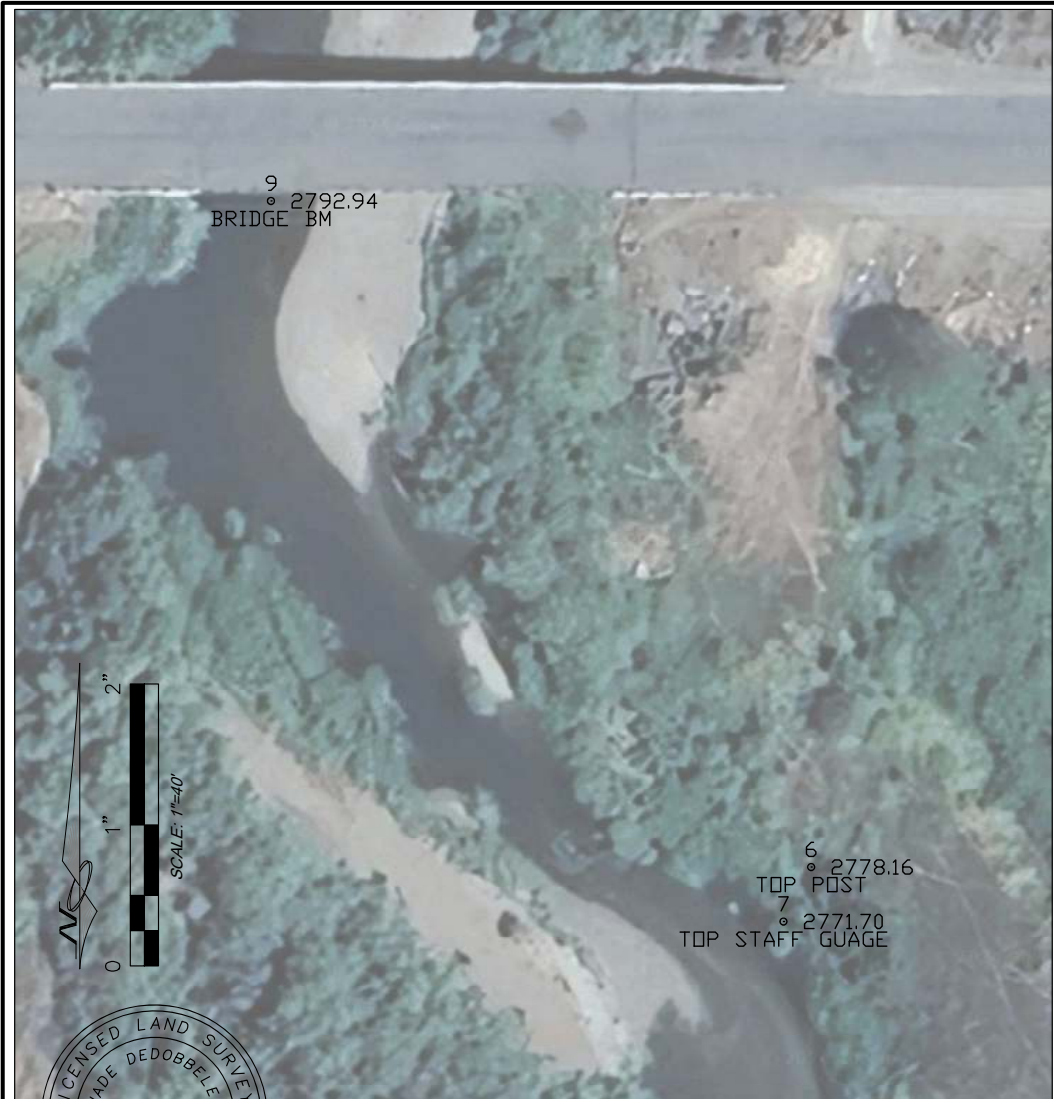
Map 2: Horn Site

ELEVATIONS ARE NAVD88 BASED ON  
NGS BENCHMARK MX0263 (W867)

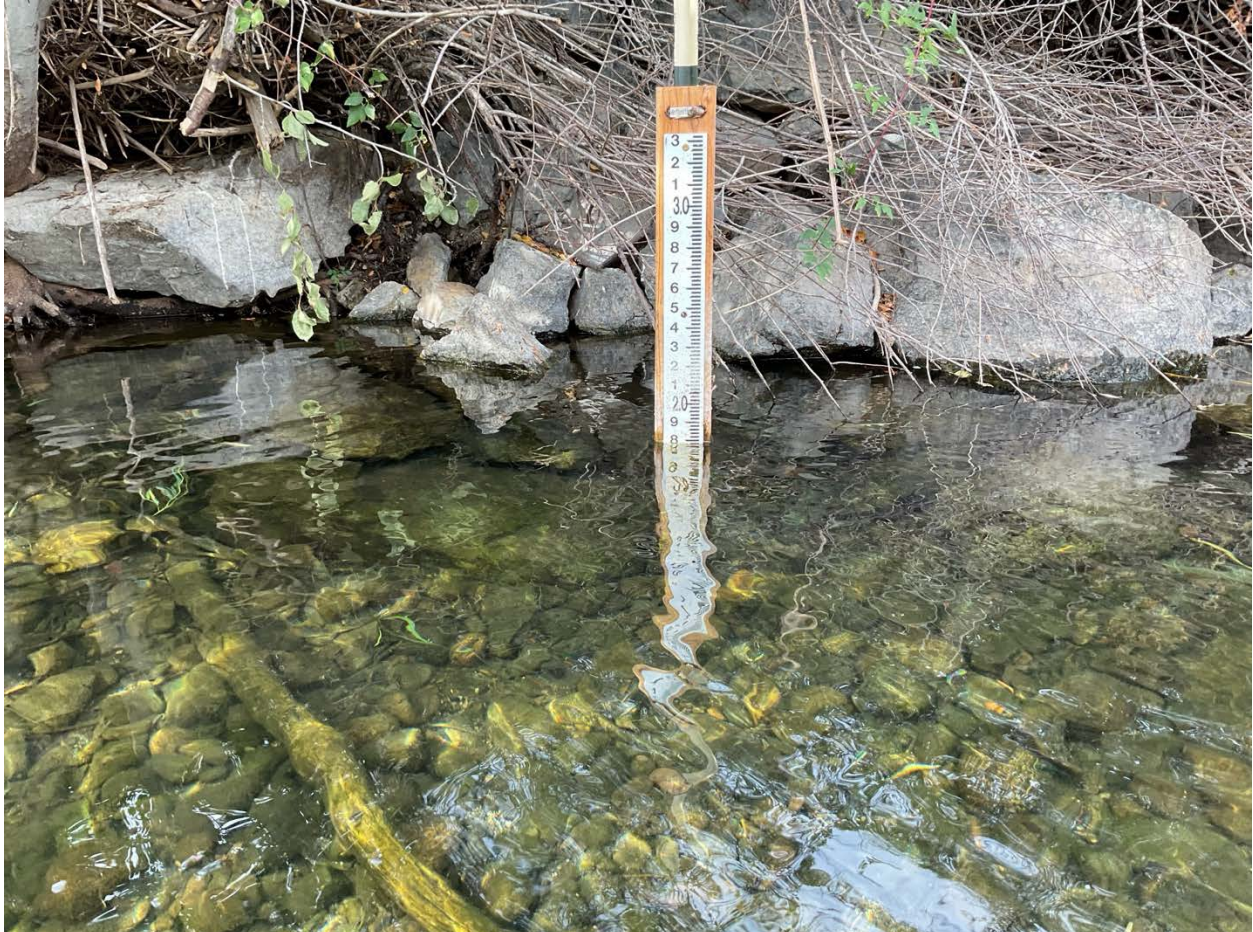
*Photo 5: Fay Site Static Staff Gage 1. (2024)*

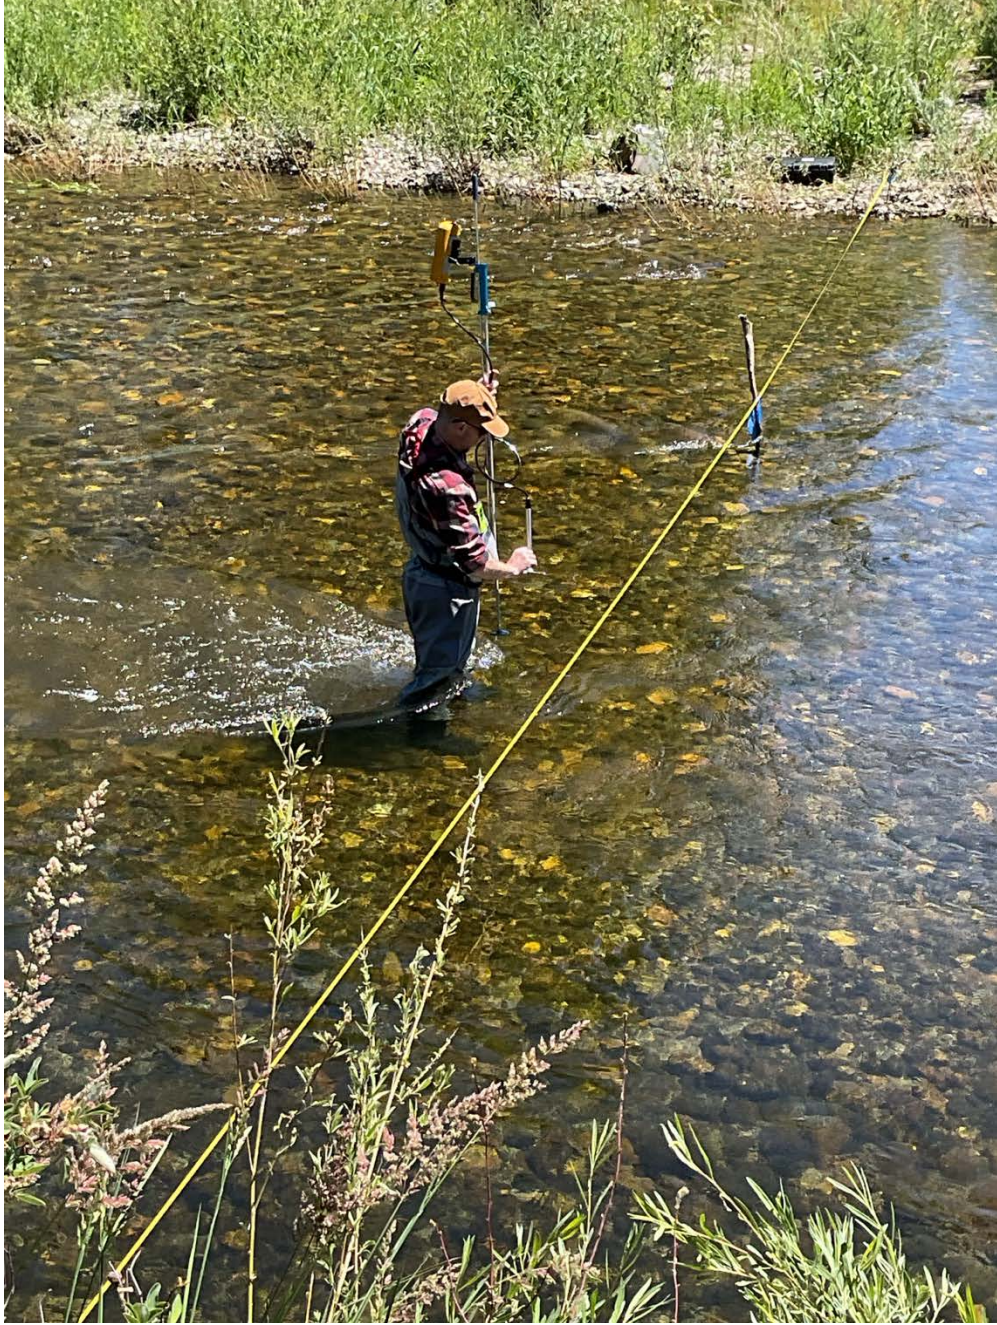
*Photo 6: Fay site flow-measurement cross-section. (SRCD, 6/17/2024).*

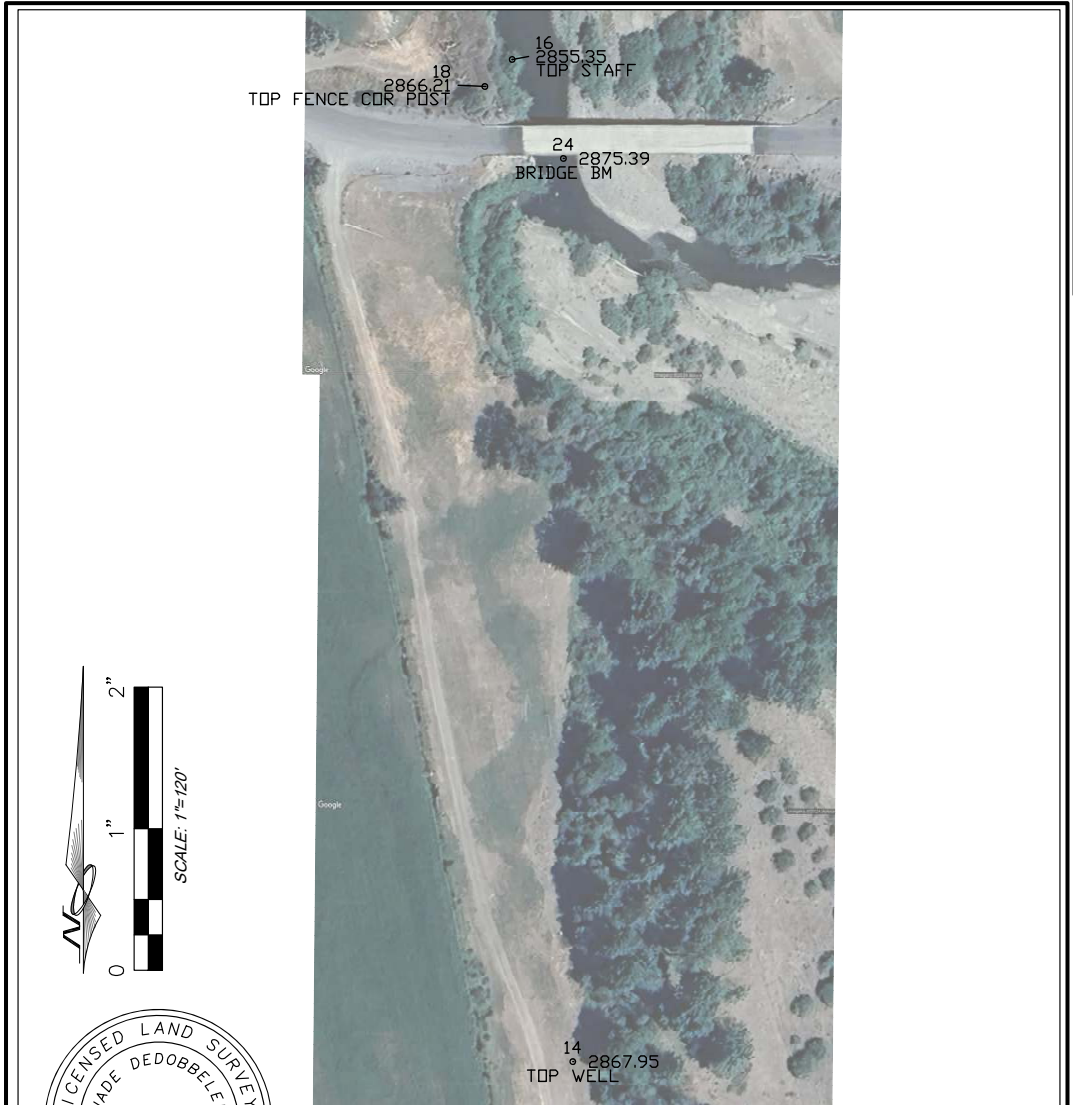
Map 3: Fay Site

ELEVATIONS ARE NAVD88 BASED ON  
NGS BENCHMARK MX0250 (12C)

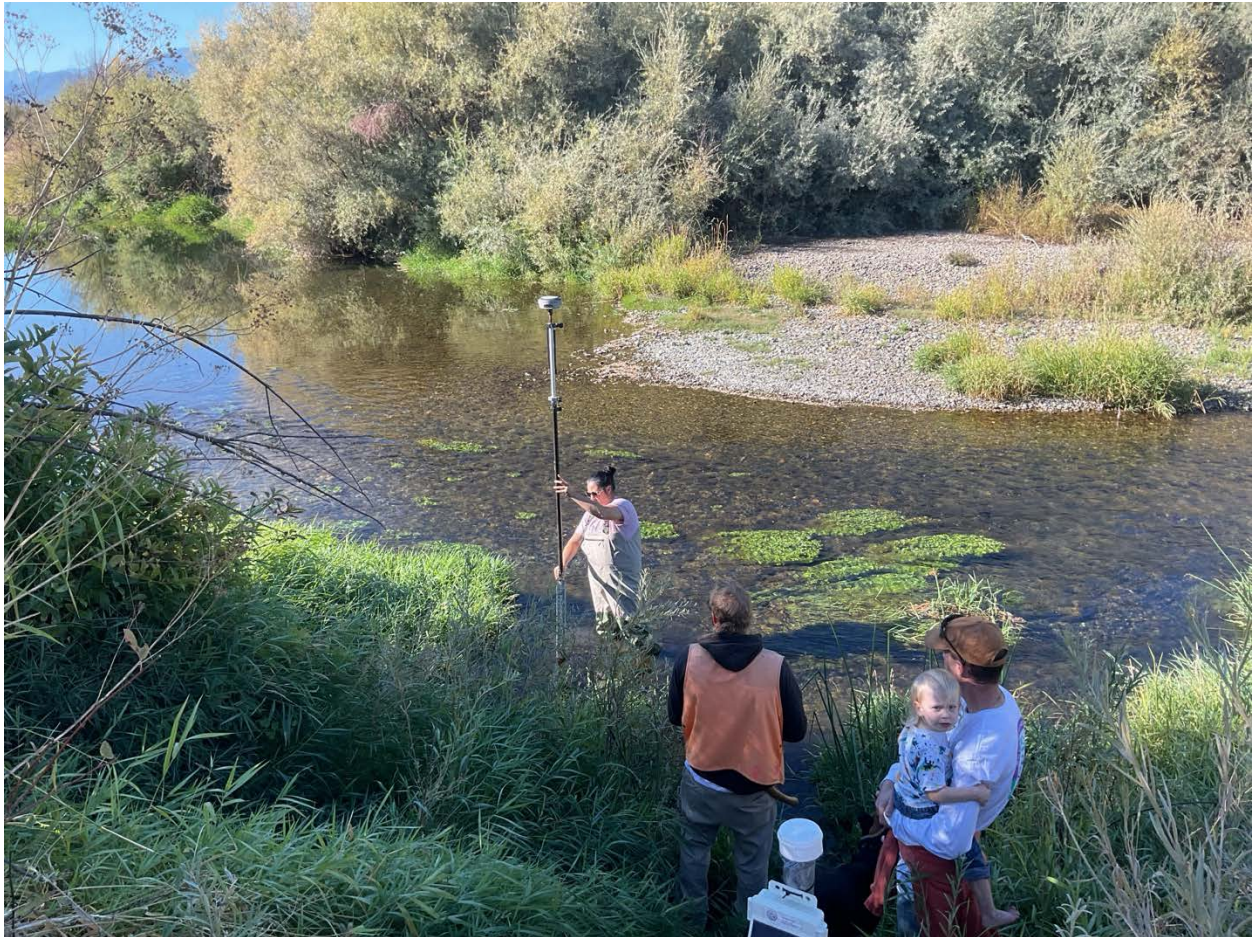
*Photo 7: SRCD Field Technician Christina J. (left) surveys the in-stream staff gage elevation at the Horn Lane Site. This is completed in coordination with Siskiyou Surveyors (Wade D. center) and overseen by SRCD Project Coordinator Evan and son Alex S. (right). (9/26/2024).*

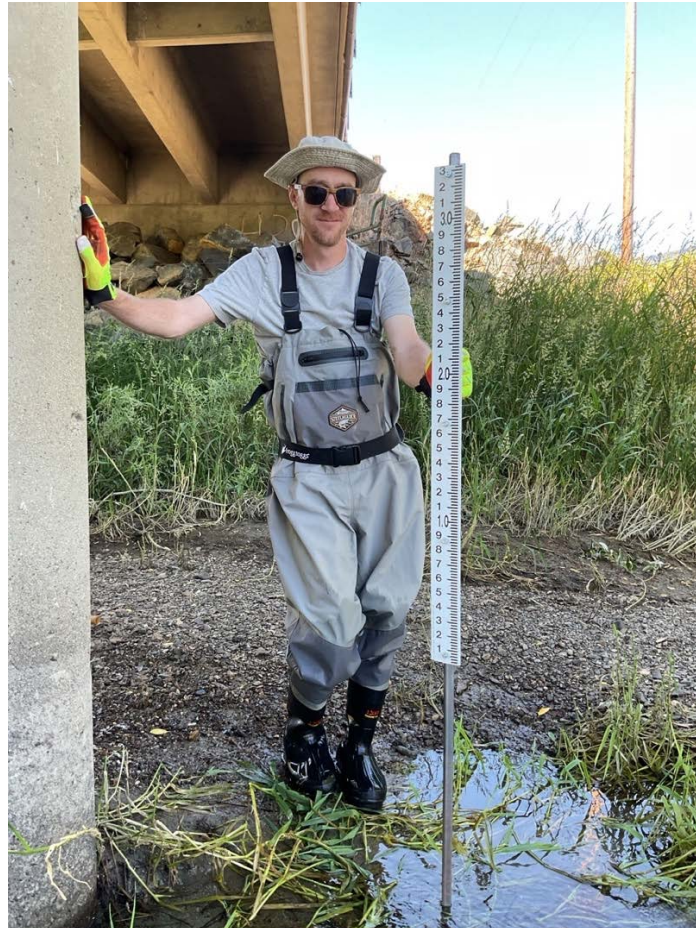
*Photo 8: 'Static' staff gage design (SRCD, 6/19/2024).*

For monitoring during water year 2024 each staff gage was statically installed by driving a 1-inch diameter, 6-foot square iron rod into the ground for (*Photo 8*). The gages were mounted to posts using metal conduit hangers. A total of three staff gages, each measuring 3.33 feet tall, were used at each site to record stages up to 9.99 feet. This configuration captures most flow situations, except for the highest floods (e.g., 5-year event).

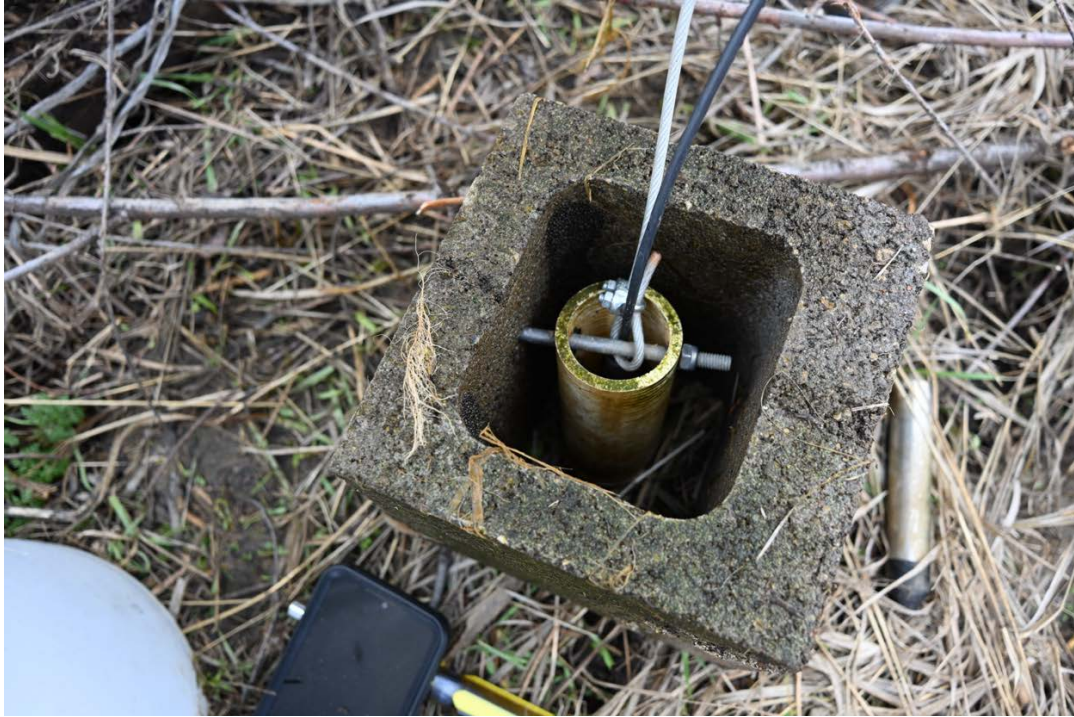
A depth sensor for remote stage monitoring was deployed near the staff gage at the river bottom. The sensor was housed in a protective PVC casing and mounted inside a stabilizing block to ensure stationary placement during high-water events (*Photo 9, 10*). The sensor's cable, running to the remote data receiver, was protected using plastic conduit and a high-abrasion-resistant soft wire sheathing.

*Photo 9: Static staff gage sensor deployment set-up, before wire protection application. (SRCD, 2025).*

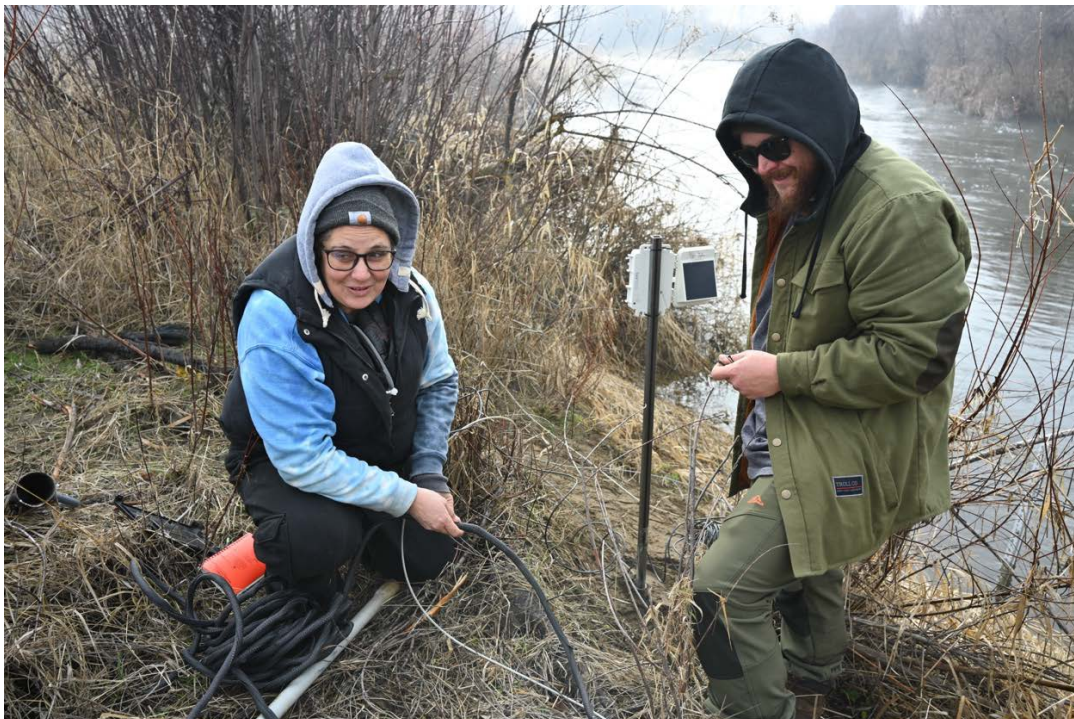
*Photo 10: Static staff gage sensor deployment wire protection application connected to remote data transmitter (hard plastic conduit and abrasion resistant soft wire sheathing are used to cover any exposed wiring, in and out of the water). (SRCD, 2025).*

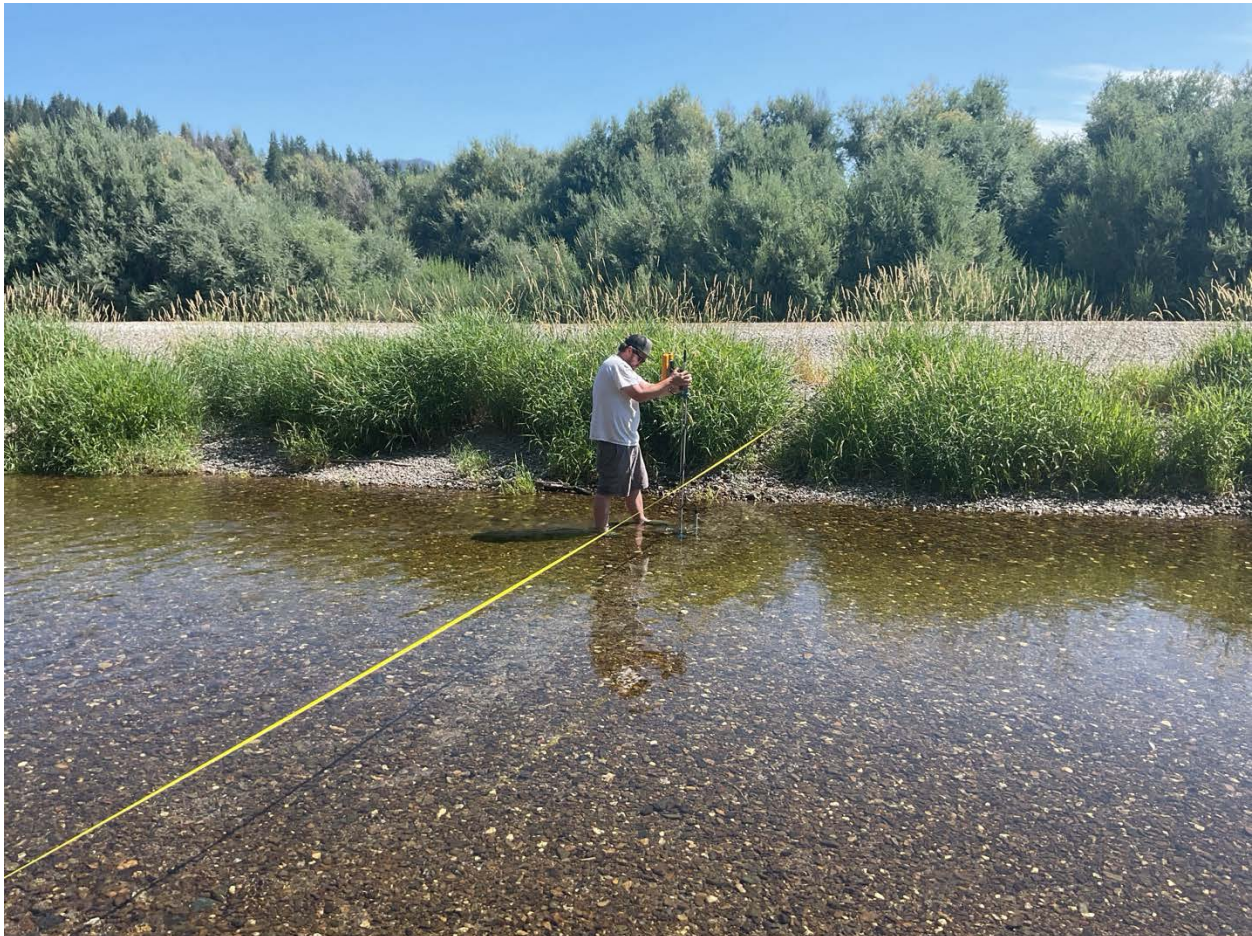
*Photo 4: SRCD Field Technician Nathan Howington, Member Site Flow Measurement (SRCD, 8/2/2024: 11:20 AM PST).*

- Flow station installation, monitoring, and first flow measurement occurred on August 25th, 2023.
- A total of fifteen (15) flow measurements were collected using a Sontek Flow Tracker 2 acoustic Doppler velocimeters for WY2024.
- Real-time data was sent via Onset RX stations (solar-powered, cellular connection) to a cloud-based application, which was calibrated with in-field flow-stage measurements. This real-time data was publicly displayed on SRCD's Streamflow Data webpage: ([www.sisjyourcd.com/streamflowdata](http://www.sisjyourcd.com/streamflowdata)).

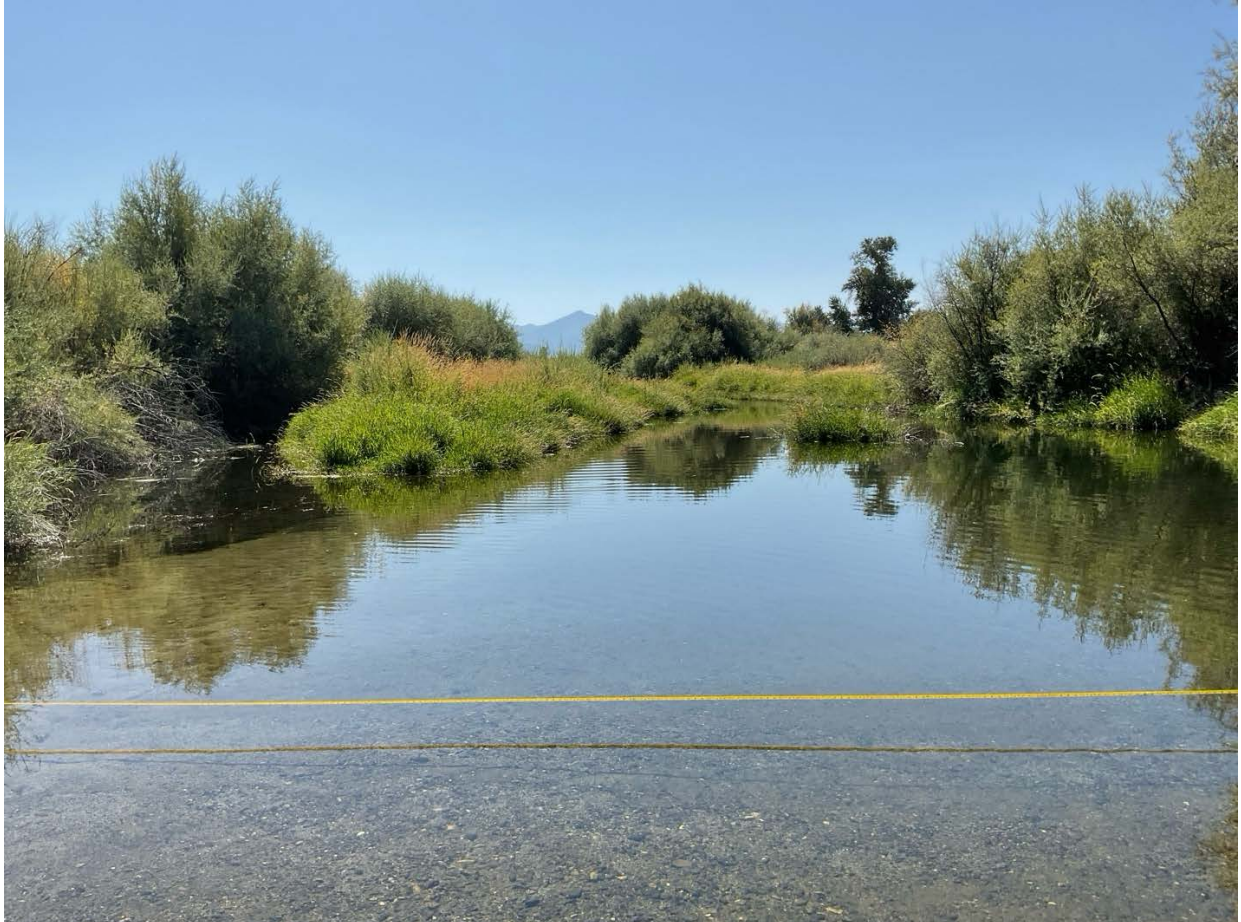
*Photo 5: Horn Site Flow-measurement Cross Section.*

- Flow station installation, monitoring, and first flow measurement occurred on September 15th, 2023.
- Monitoring equipment was removed on November 28th, 2023, to prevent loss during high water.
- A damaged data cable prevented real-time monitoring; a replacement was purchased for WY2024.
- A total of fifteen (15) flow measurements were collected using a Sontek Flow Tracker 2 acoustic Doppler velocimeters.

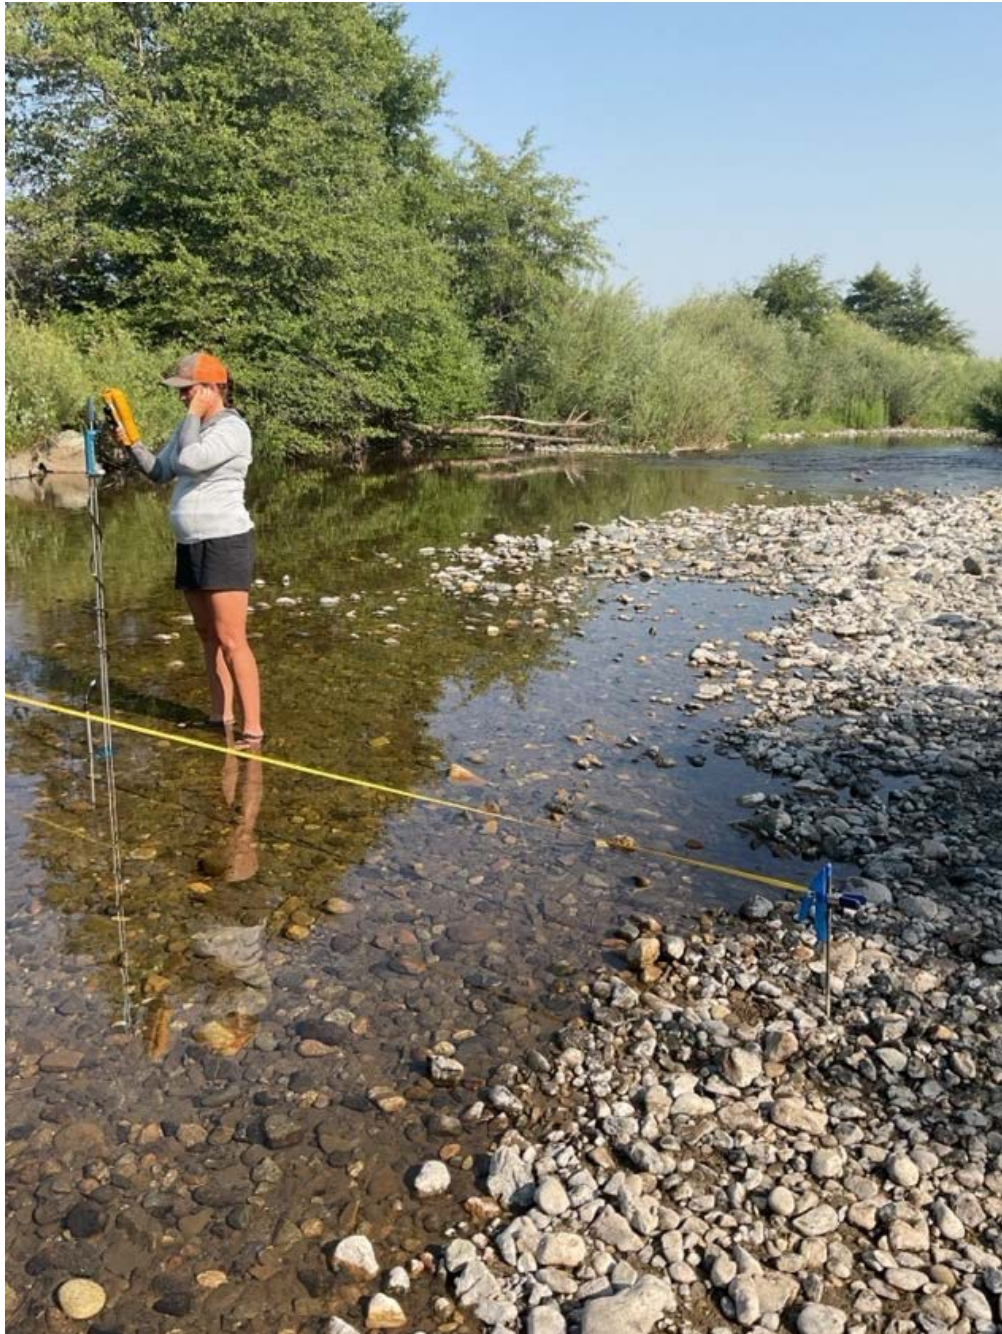
*Photo 6: (Left, looking downstream) Low-water flow measurement at Fay Lane site (SRCD, 9/12/2024).*

- Flow station installation, monitoring, and first flow measurement occurred on August 24th, 2023.
- Monitoring equipment was removed on November 28th, 2023, to prevent loss during high water.
- A total of fifteen (15) flow measurements were collected using a Sontek Flow Tracker 2 acoustic Doppler velocimeters.

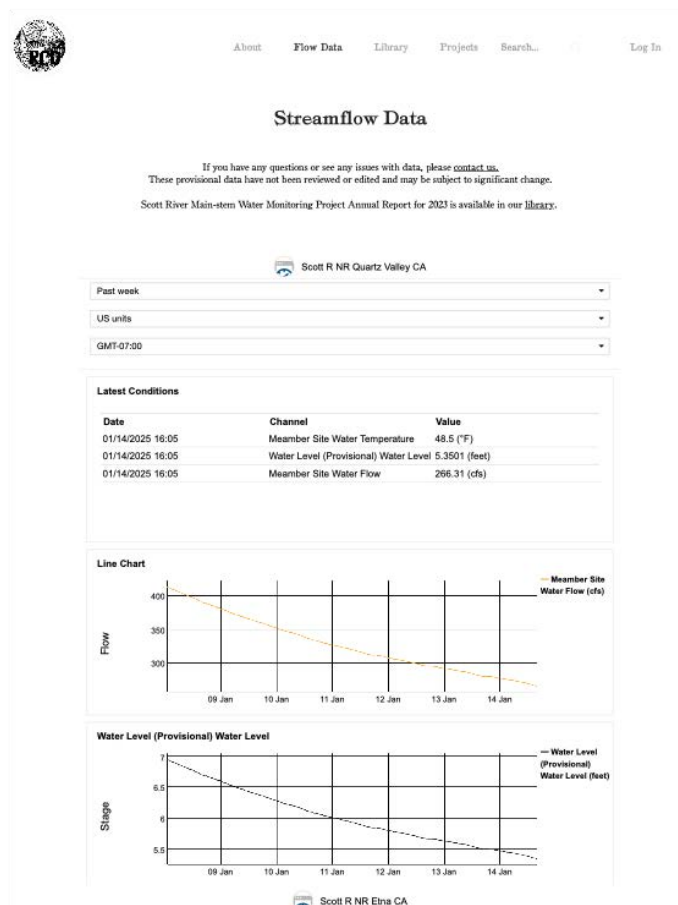
Photo 7: [www.siskiyoucd.com/streamflowdata](http://www.siskiyoucd.com/streamflowdata) screenshot.

Real-time surface-water flow, temperature and stage data for the Meamber, Horn and Fay sites were made publicly available on SRCD's Streamflow Data webpage, ensuring transparency and accessibility ([link: www.siskiyoucd.com/streamflowdata](http://www.siskiyoucd.com/streamflowdata)).

Data from the Meamber, Horn and Fay staff gage stations were automatically uploaded to a cloud-based application (hobolink) based on user-preference timing intervals (typically between 5-20 minutes each remote measurement per sensor), calibrated against field-measured flow-stage data, and used to calculate stage, discharge, WSE, GWT, and SWT.

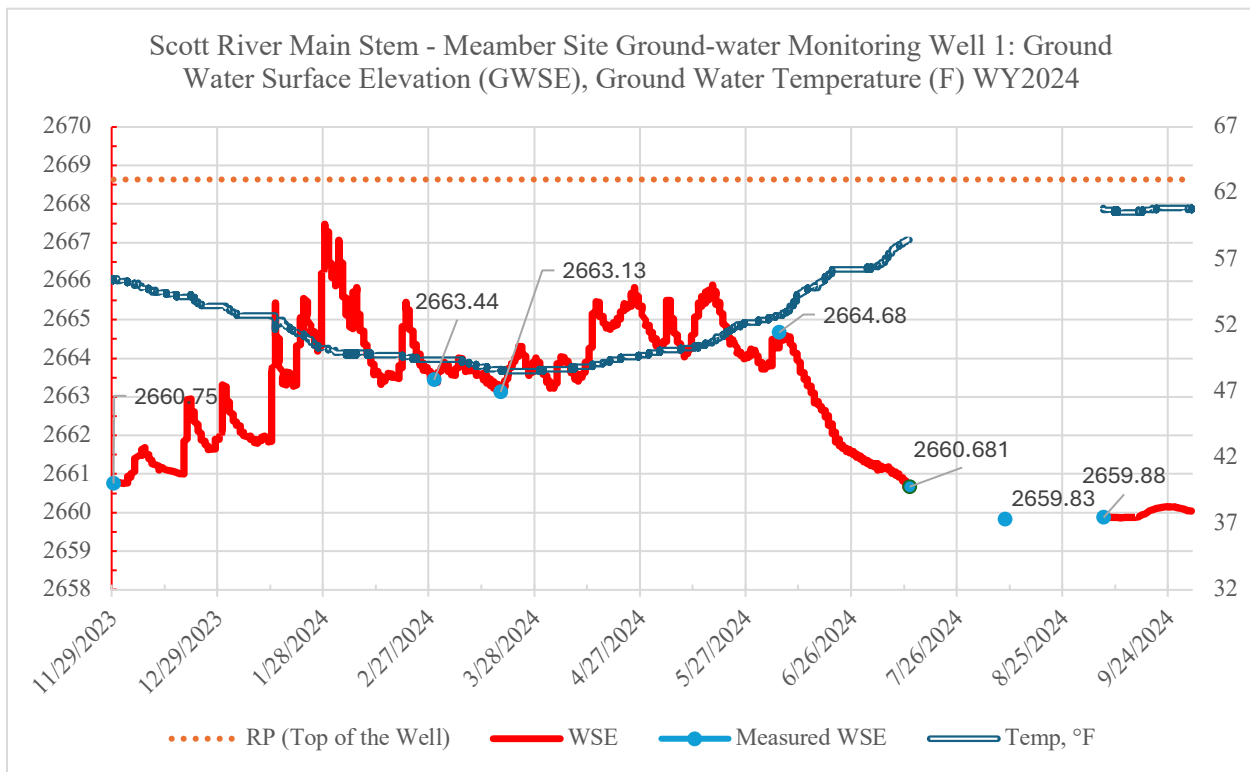
With less than 100 feet separating the well from the river, rapid responses in GWSE to river stage changes confirm strong connectivity. Seasonal divergence (e.g., open-ditch irrigation) is not indicative of localized aquifer depletion from agricultural withdrawals.

Groundwater temperatures remain buffered compared to surface water, with a peak of 67°F in late summer aligning with increased surface heating and reduced subsurface flow. The observed gradient indicates that during high river stages, the aquifer likely recharges, whereas during low stages, groundwater may supplement baseflow.

Figure 1: Scott River Main Stem - Meamber Site Groundwater Monitoring Well 1: Ground Water Surface Elevation (GWSE), Ground Water Temperature (f) WY2024.

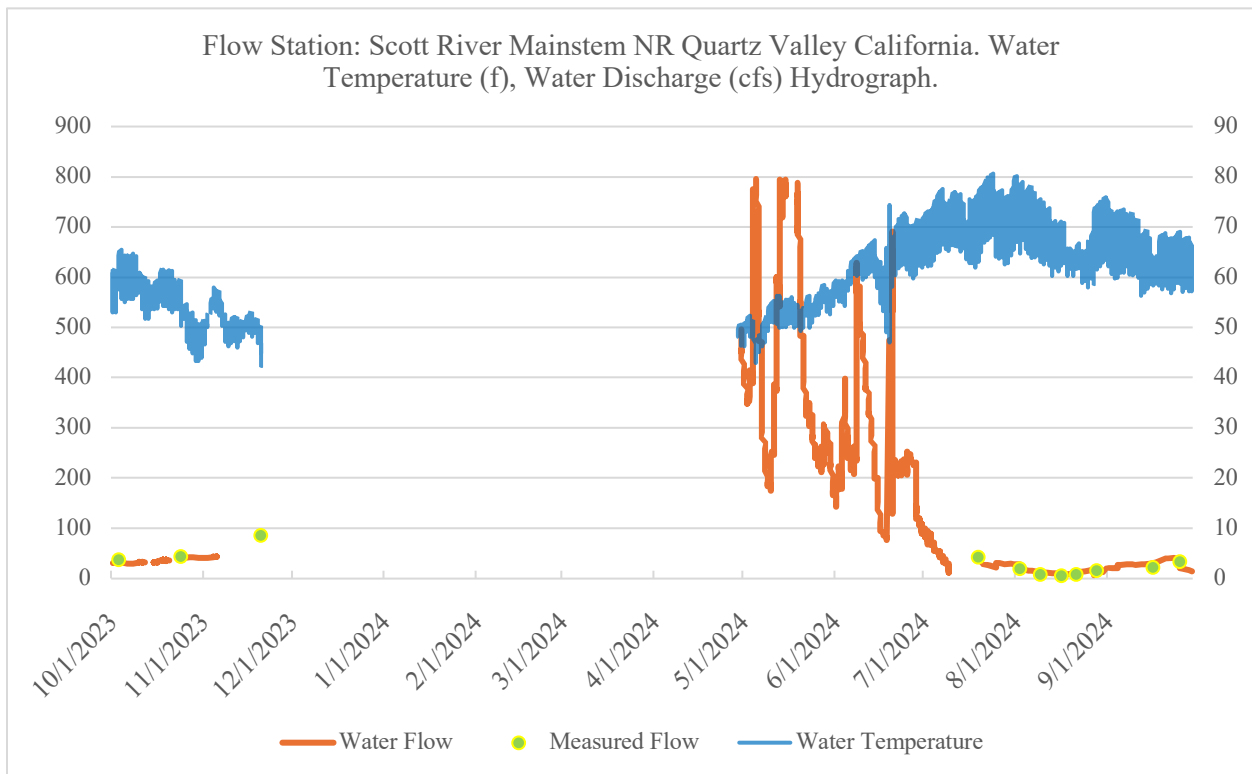
Surface-water temperatures ranged from just above freezing (32°F) during the winter to peaks above 76°F in the summer. This seasonal surface water temperature increase coincides with lower flows and warmer air temperatures. Elevated surface-water temperatures during low-flow periods in the late summer emphasize the potential for thermal stress on aquatic species, especially salmonids such as coho (Moyle, 1991).

Figure 2: Flow Station: Scott River Mainstem NR Quartz Valley California. Water Temperature (F), Water Discharge (Cubic Feet Per Second) Hydrograph.
