# *Scott River Main-stem Flow and Water Quality Monitoring Project (2023–2025)*

## 2024 Annual Report

*Prepared for: Siskiyou RCD. Prepared by: Evan Senf. Funding Provided by: California Department of Fish and Wildlife (CDFW) & Siskiyou Resource Conservation District (SRCD) (\$309,281.09).*

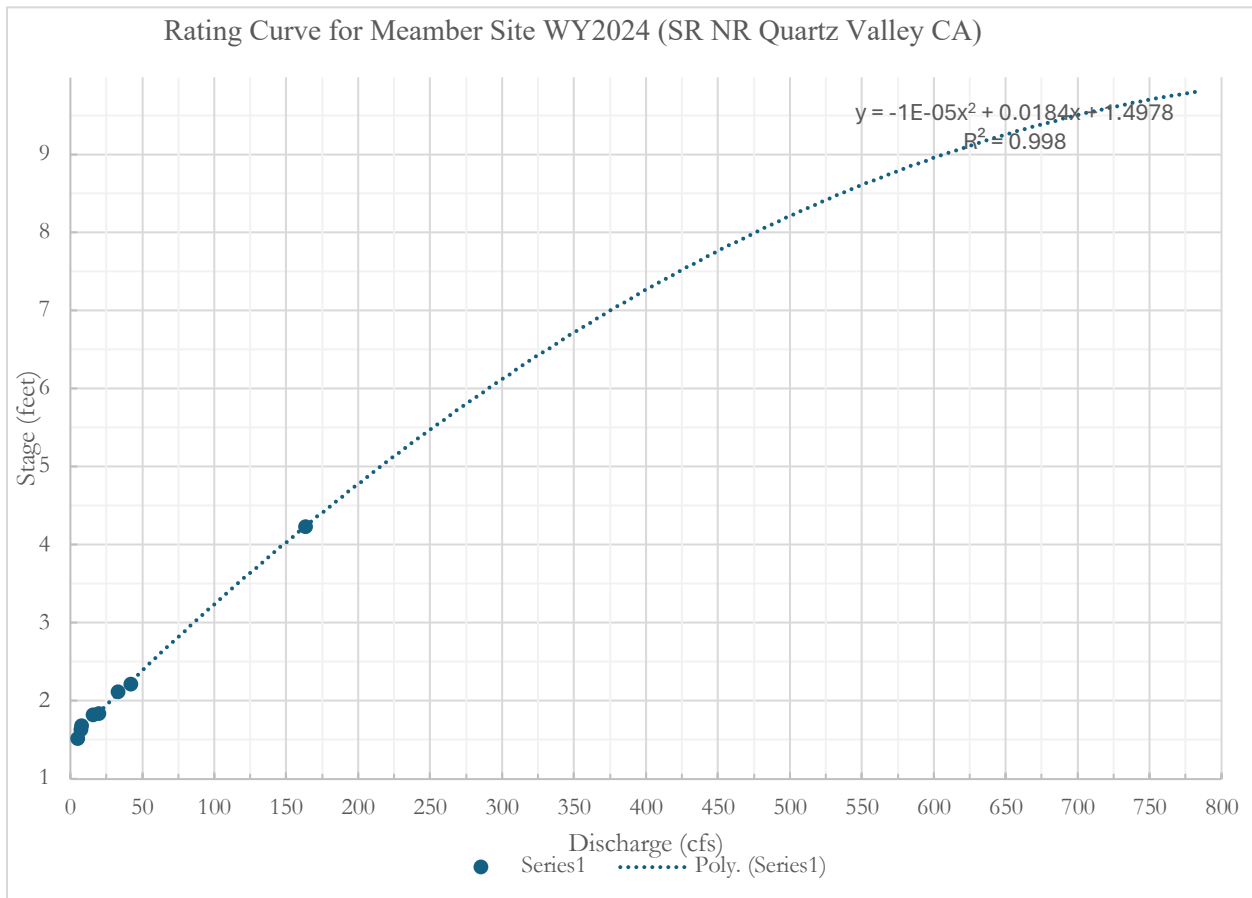
The channel's expansive width and depth create significant storage capacity during medium to high flows. This capacity influences how discharge scales with stage, as evidenced by the curve's non-linear behavior.

Flow at this site reflects cumulative inputs from upstream sources, including irrigation return flows, tributaries, and localized runoff. The significant width and storage effect suggest slower changes in stage compared to narrower sections upstream. The polynomial curve captures complexities introduced by the channel's geometry, which impacts flow velocity and depth distributions at varying discharges (*Figure 3*).

*Figure 3: Rating Curve for Meamber Site WY2024 (SR NR Quartz Valley CA)*

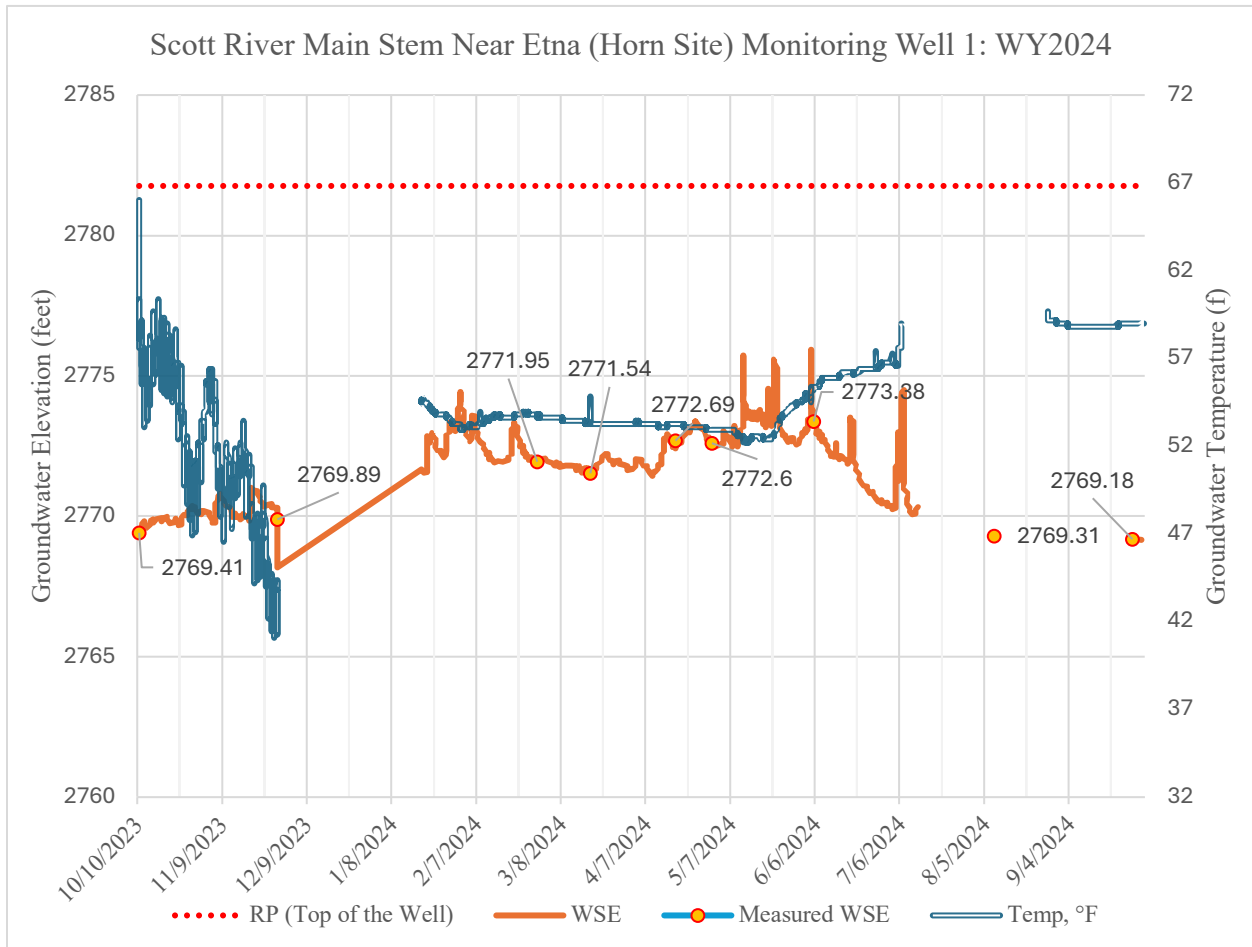
Data underscores the importance of groundwater contributions to maintaining flow, particularly during dry periods. Enhanced monitoring and modeling of groundwater inputs are critical for sustainable management. Monitoring return flows from the SVID diversion is vital to understand their role in mitigating downstream flow reductions. High flows at Horn Lane reinforce the need to preserve hydrological connectivity upstream and downstream to sustain ecological health.

Figure 4: Scott River Main Stem Near Etna (Horn Site) Monitoring Well 1: WY2024.

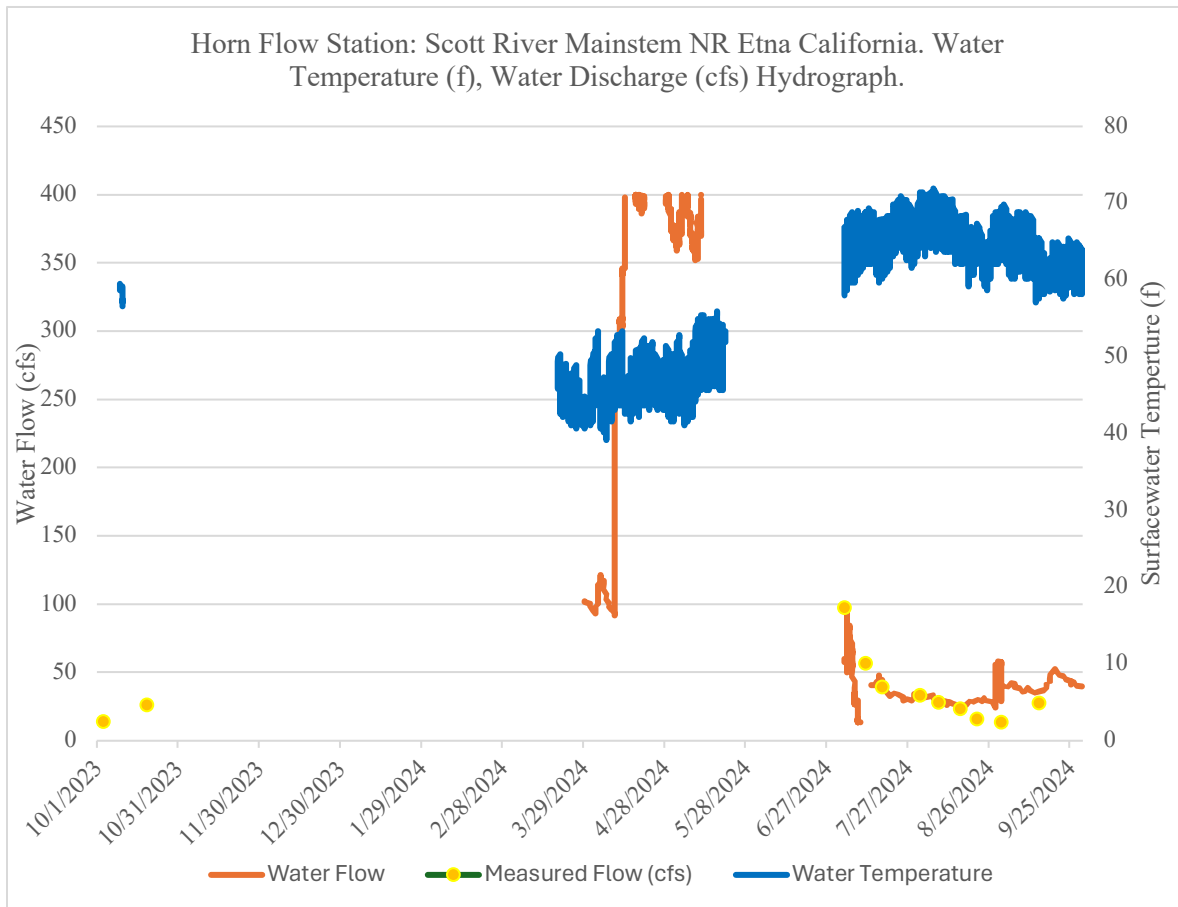
Flow at the Horn site displayed notable seasonal variability, with peak measured discharges during spring snowmelt (March through May) reaching more than **100 cubic feet per second (cfs)**. In contrast, summer months (July through September) recorded the lowest flows, with measured discharges dropping below **15 cfs**, reflecting seasonal irrigation withdrawals and diminished tributary contributions. These low-flow periods coincide with elevated water temperatures, which peaked above **70.5°F**, emphasizing the heightened risk of thermal stress to aquatic ecosystems during late summer.

The hydrograph highlights the critical relationship between flow and temperature, with increased discharge in spring maintaining cooler water temperatures, while reduced flows in summer exacerbate warming trends. These findings underscore the importance of maintaining sufficient base flows during critical low-flow periods to support ecological health and ensure water quality. The Horn site data offers valuable insights for managing mid-basin water resources and addressing flow-temperature interactions under varying seasonal conditions.

Figure 5: Horn Site Staff Gage WY2024 discharge and surface-water temperature comparison hydrograph.

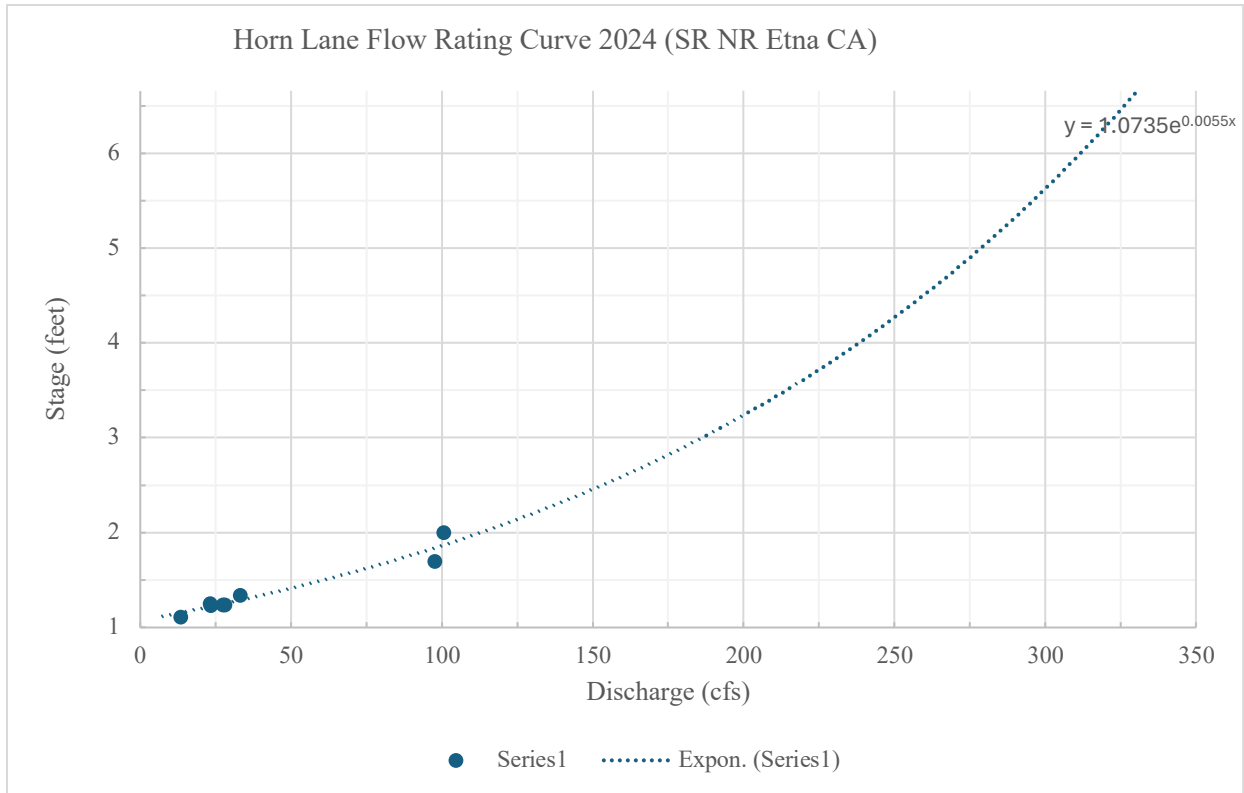
The exponential relationship reflects the influence of the site's geomorphology, particularly its role in accommodating variable flows. At lower discharges, stage changes are gradual, indicating stable low-flow conditions. However, as discharge increases, the stage rises more sharply, signifying the site's capacity to handle high flows while maintaining channel stability. This dynamic is particularly evident during peak discharge events observed in the spring snowmelt period.

This curve is essential for understanding the hydrological impacts of upstream diversions, such as those by SVID maintaining accurate calibration to track seasonal variations and to inform water management practices. The refined rating curve will contribute to improved monitoring and analysis for future water years.

Figure 6: Horn Lane Flow Rating Curve 2024 (SR NR Etna CA).

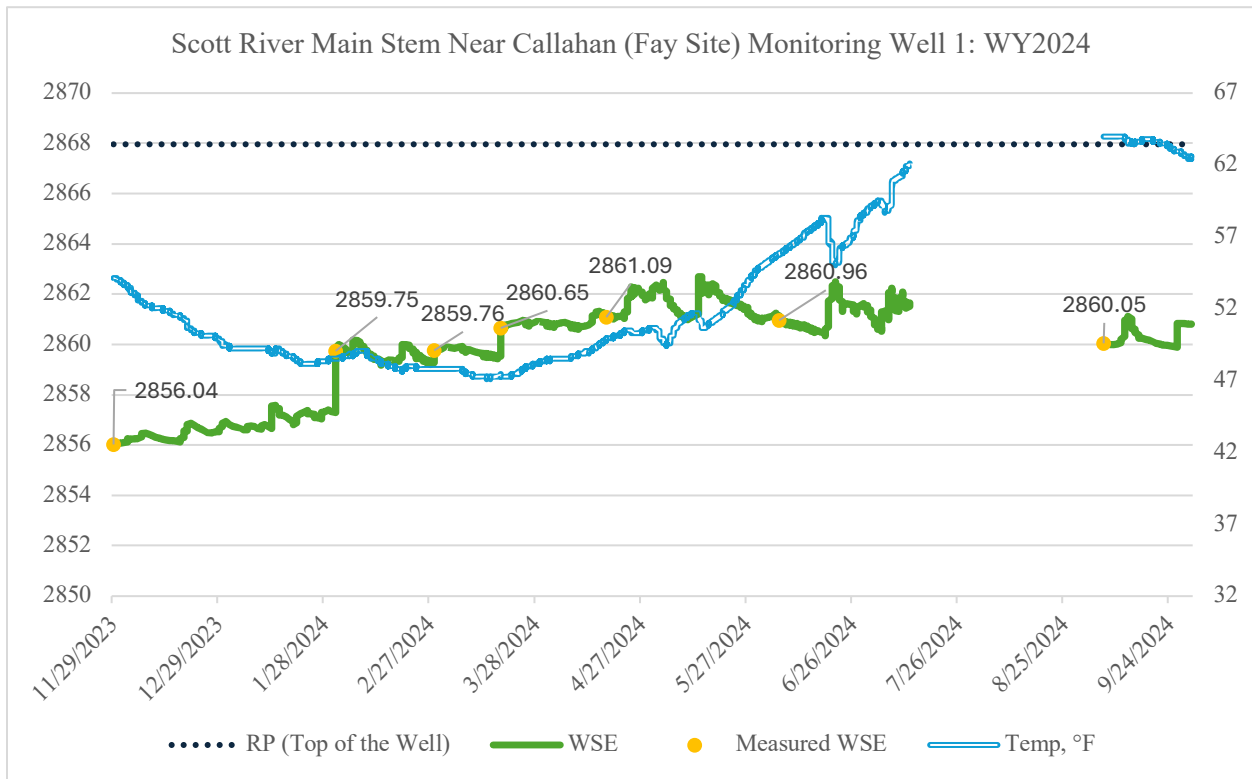
The Fay Lane monitoring well 1 is located near Callahan, California and positioned above the floodplain by less than 10 feet in elevation, more than 200 feet adjacent to the main stem of the Scott River, on river left. This well provides critical data on groundwater conditions in proximity to, but not directly within, the active floodplain.

Groundwater temperatures are stable during winter, gradually increasing with seasonal warming to a peak of <67F in late summer, driven by ambient air temperatures and potentially influenced by surface water interactions. The distance of over 200 feet from the Scott River reduces direct hydrological interactions, with GWSE trends more influenced by local precipitation and subsurface flow rather than immediate river-stage dynamics.

The well's separation from the river suggests that its groundwater levels are more indicative of broader aquifer conditions rather than direct river-aquifer exchanges. The summer drawdown emphasizes the need for sustainable aquifer management to support regional water availability during dry periods.

Figure 7: Scott River Main Stem Near Callahan (Fay Site) Monitoring Well 1: WY2024.

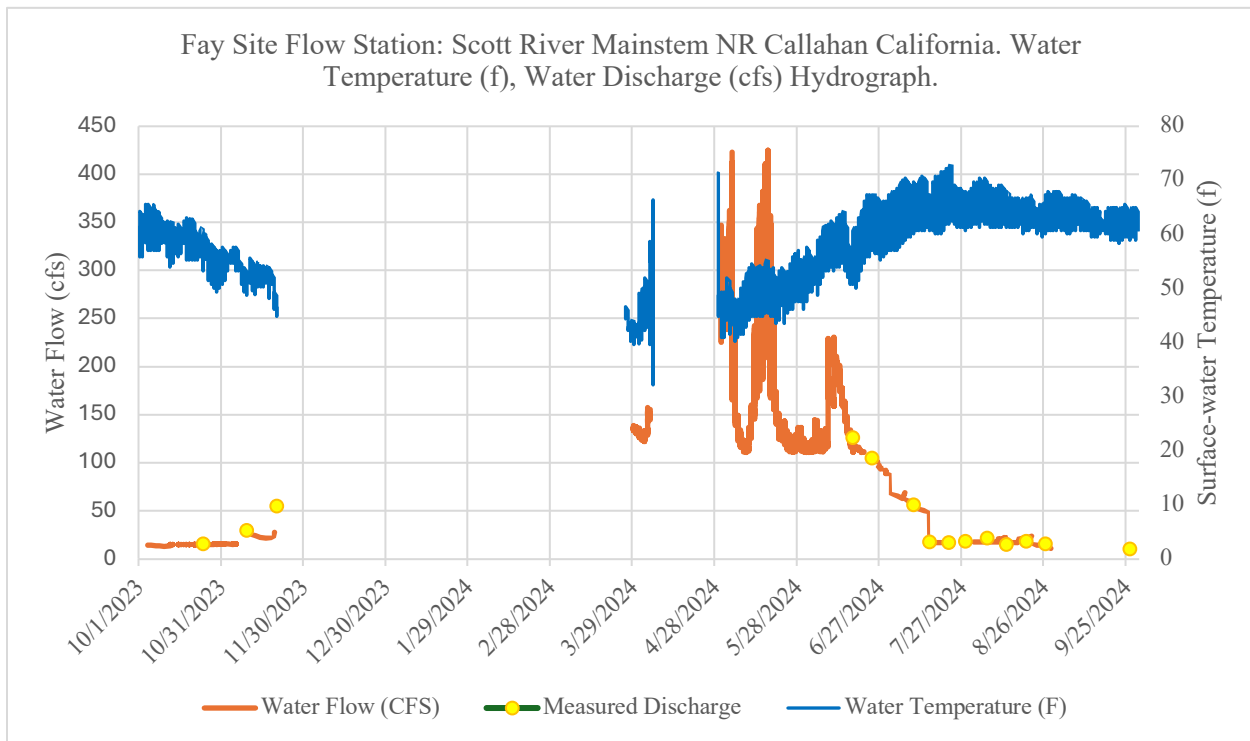
The hydrograph for the Fay site, located near Callahan, California, captures seasonal variations in water flow (discharge) and surface water temperature across Water Year 2024. This site is situated in the upstream portion of the monitoring network and provides valuable insights into the flow and thermal conditions at the headwaters of the Scott River.

Water temperature trends mirrored these seasonal variations, with cooler temperatures during high-flow periods in the spring and elevated temperatures exceeding **72°F** during low-flow periods in the summer. These conditions underscore the critical connection between flow and thermal dynamics, with reduced flows amplifying the risk of thermal stress on aquatic species during the late summer months.

The data from the Fay site hydrograph is essential for understanding upstream contributions to the Scott River's flow and temperature regimes. This information serves as a baseline for evaluating downstream conditions and highlights the need for effective water management practices to sustain ecological health during critical low-flow periods.

Figure 8: Fay Site Staff Gage WY2024 discharge and surface-water temperature comparison hydrograph.

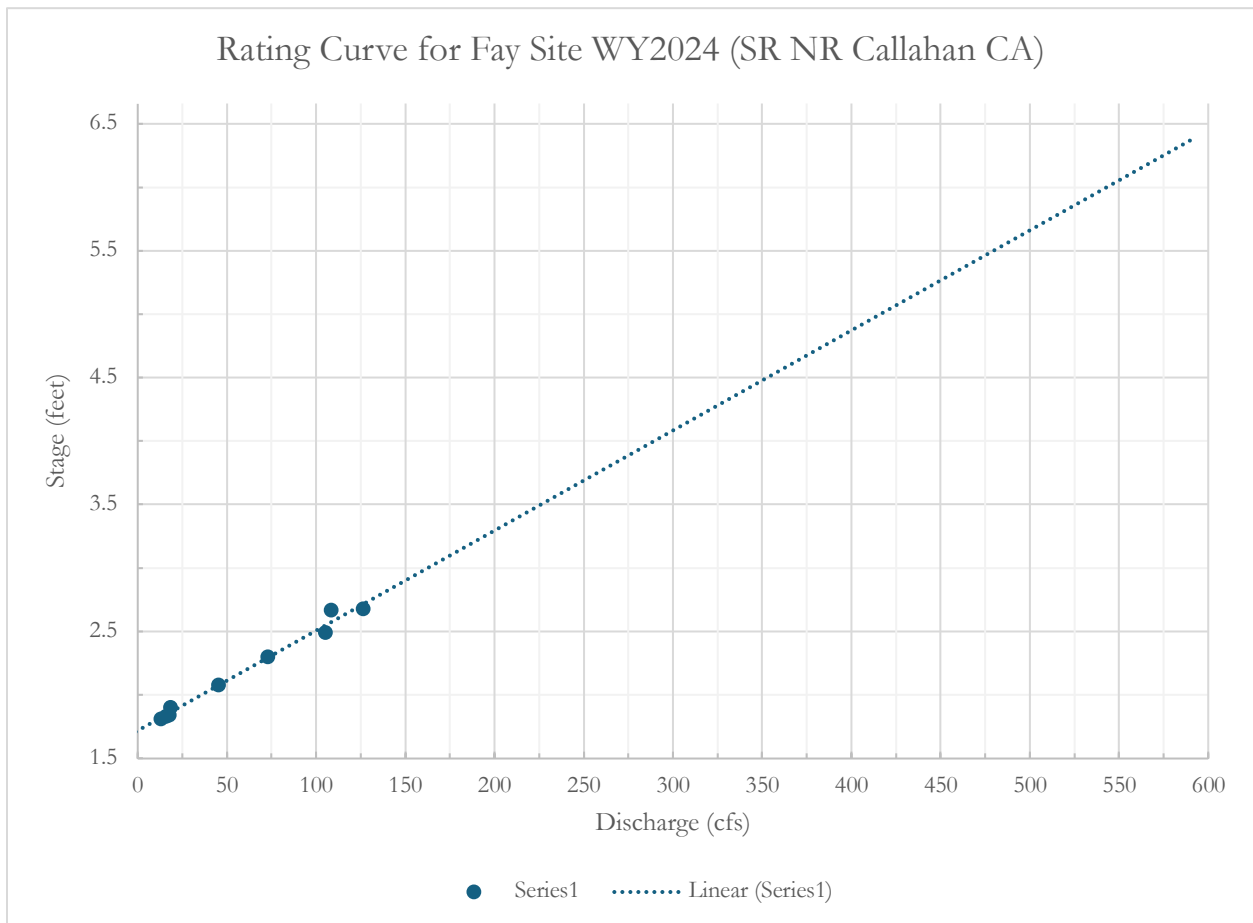
The mining tailings upstream likely influence the flow regime by altering sediment dynamics and channel morphology, which may create deviations in the rating curve under extreme flows or channel alterations.

The observed discharge data underscores the importance of maintaining flows above low-flow thresholds during dry periods to support ecological health. The tailings area upstream may contribute to irregular flow patterns and sedimentation, necessitating targeted restoration efforts to stabilize and enhance flow dynamics. Given the sensitivity of this site to upstream conditions, continued monitoring is vital for detecting changes in the rating curve over time, which may result from sediment redistribution or restoration efforts.

Figure 9: Rating Curve for Fay Site WY2024 (SR NR Callahan CA).
